PROPOSED NEW HOUSE 110 AYRES ROAD RANELAGH

GEOTECHNICAL SUMMARY

Municipality
Client
Location
Development
Date of inspection

Huon Valley
I and J Urquhart
110 Ayres Road, Kettering
New house
6 May 2014

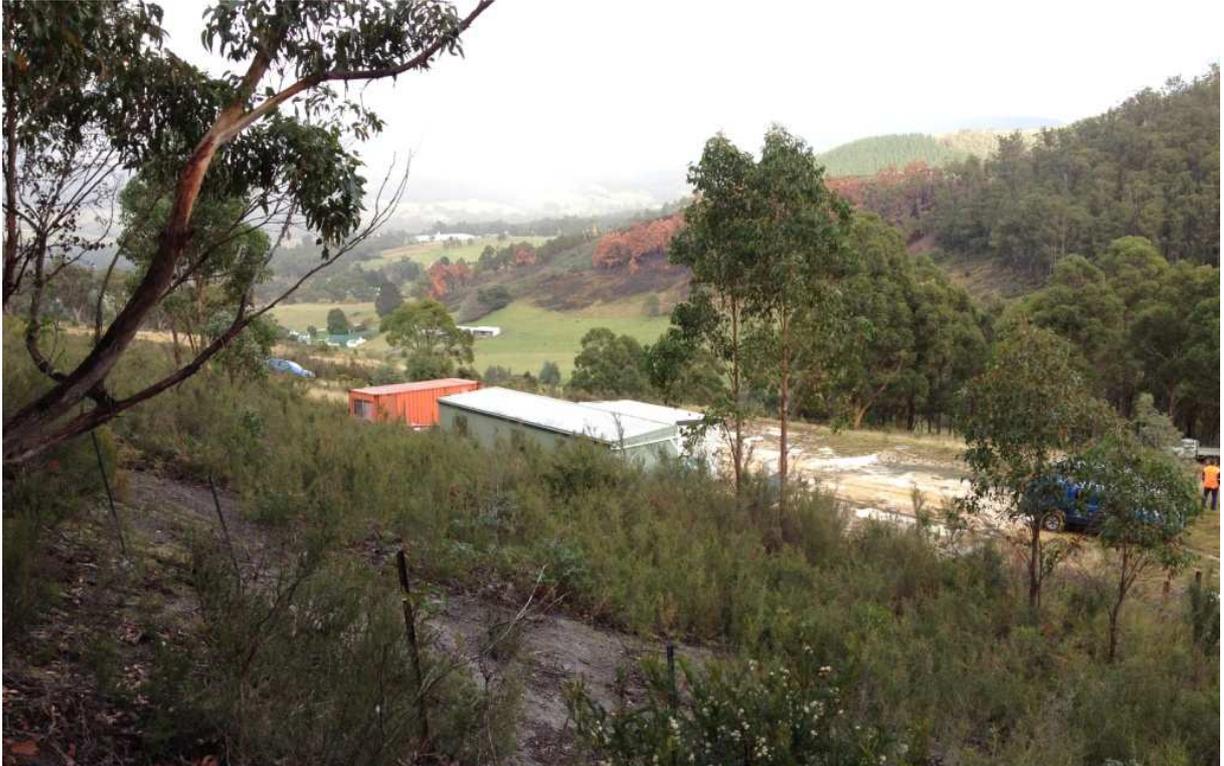
Plate 1 (above). View southeast and downslope towards the pad for the house (to be built at right of the existing buildings). The slopes in the foreground are 25 – 30°.

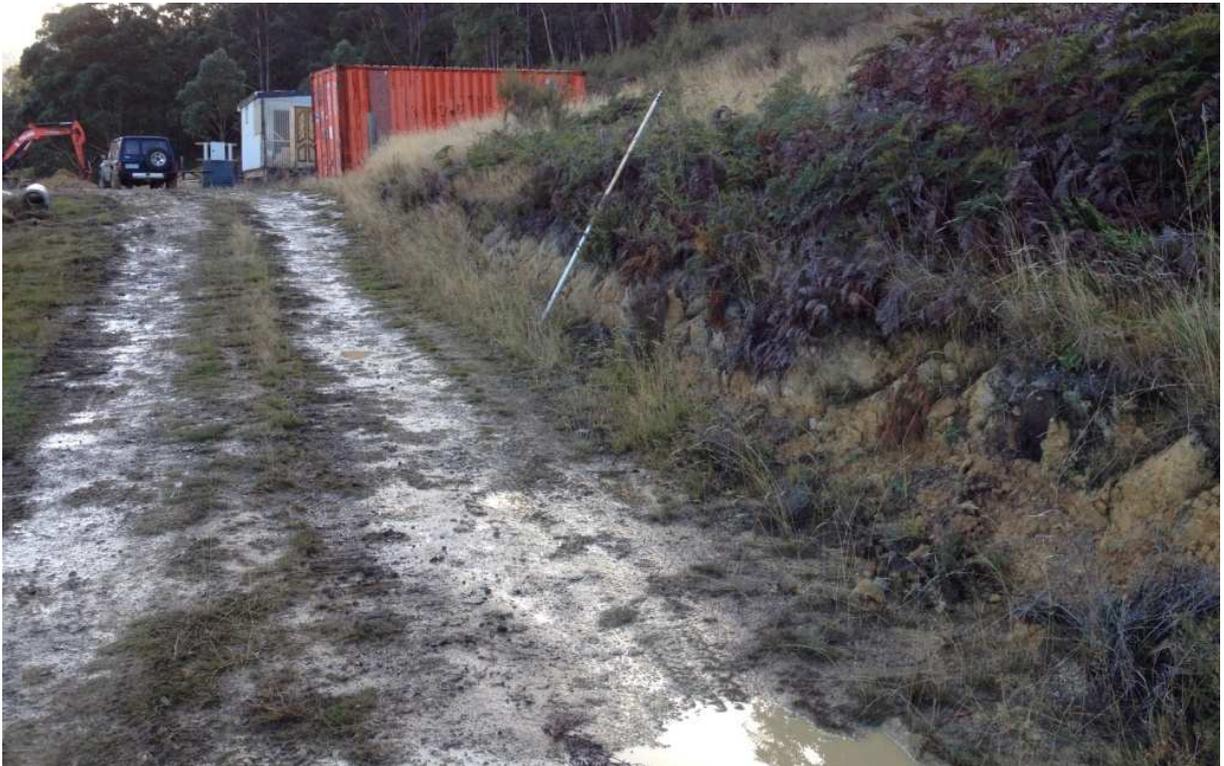
Plate 2 (below). View north towards the house pad from the access drive. The low bank at right has been cut through an inferred small shallow translational landslide (activity unknown).

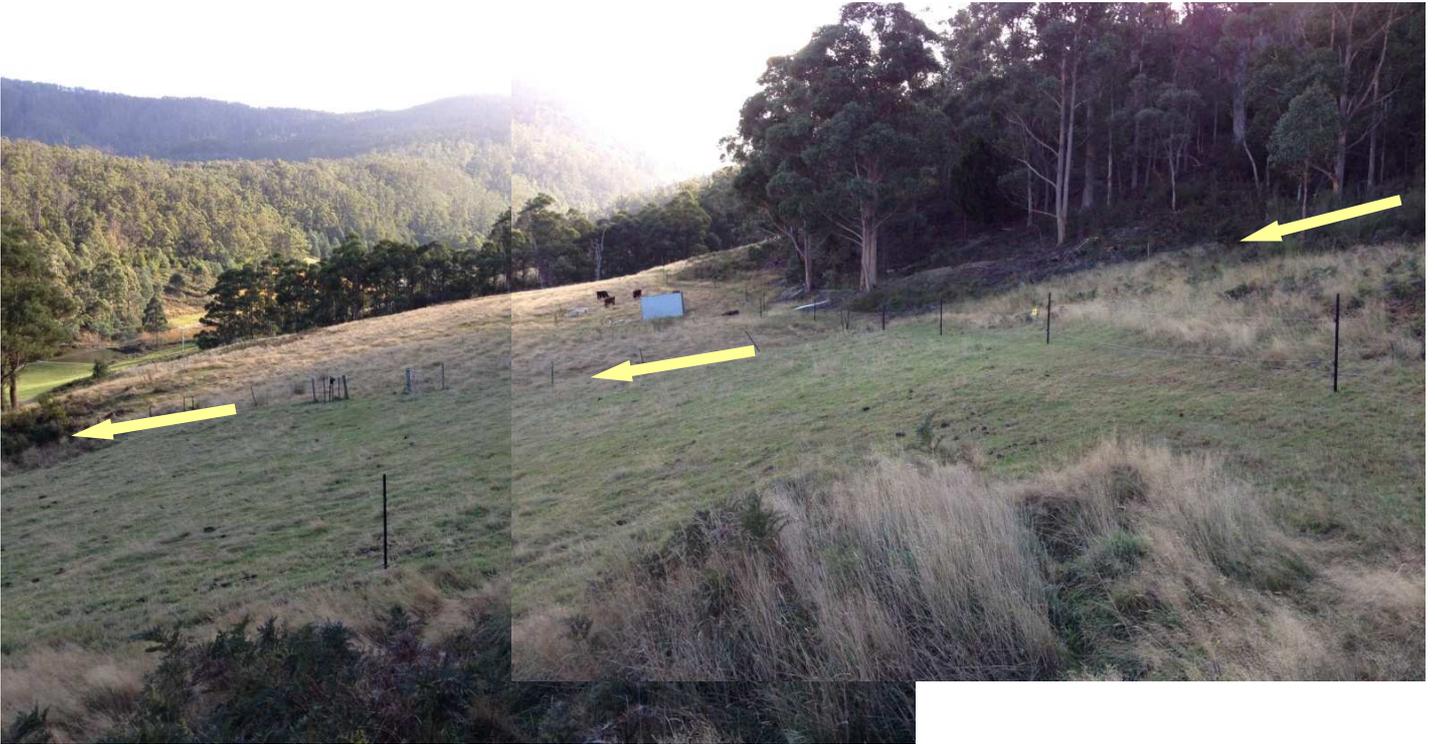
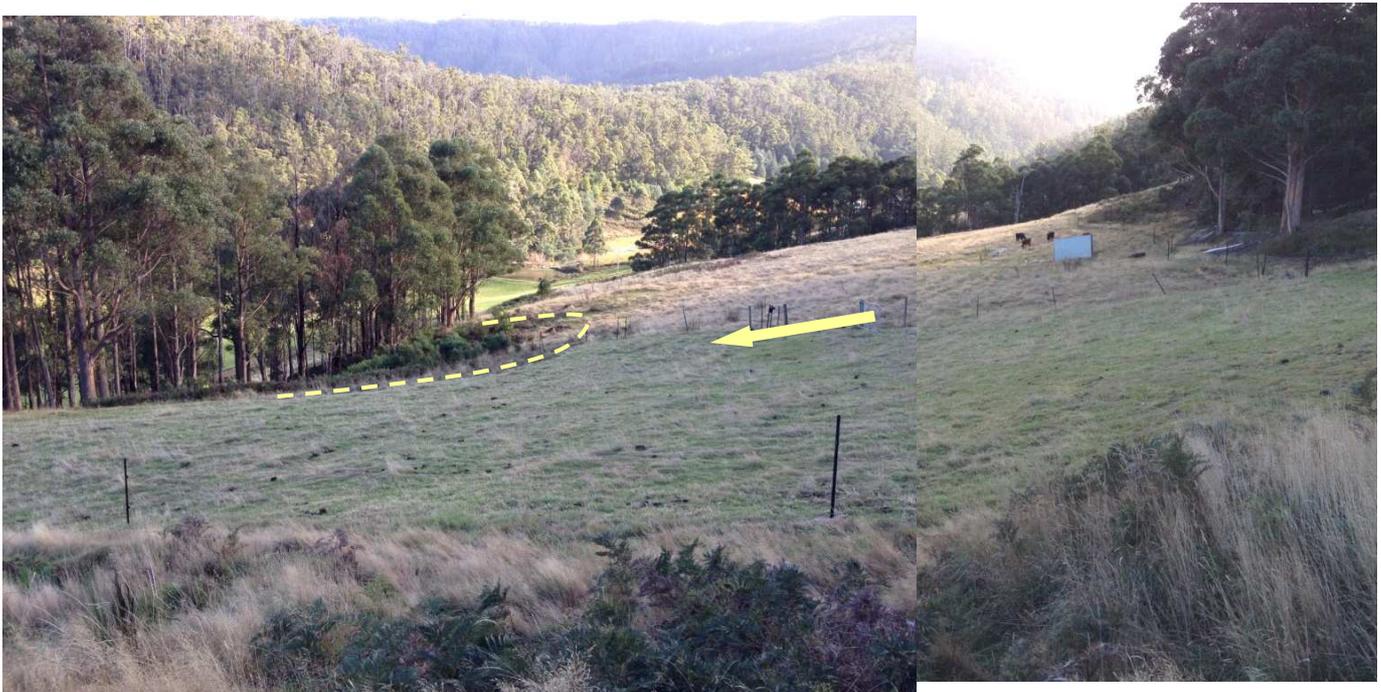
Plates 3 (above) and 4 (below). View north from the house pad. The shallow valley in the middle ground is inferred to be the run-out line (arrowed) of a medium sized shallow translational landslide (probably inactive) which originated on thin colluvial soils on 25 – 30° slopes.

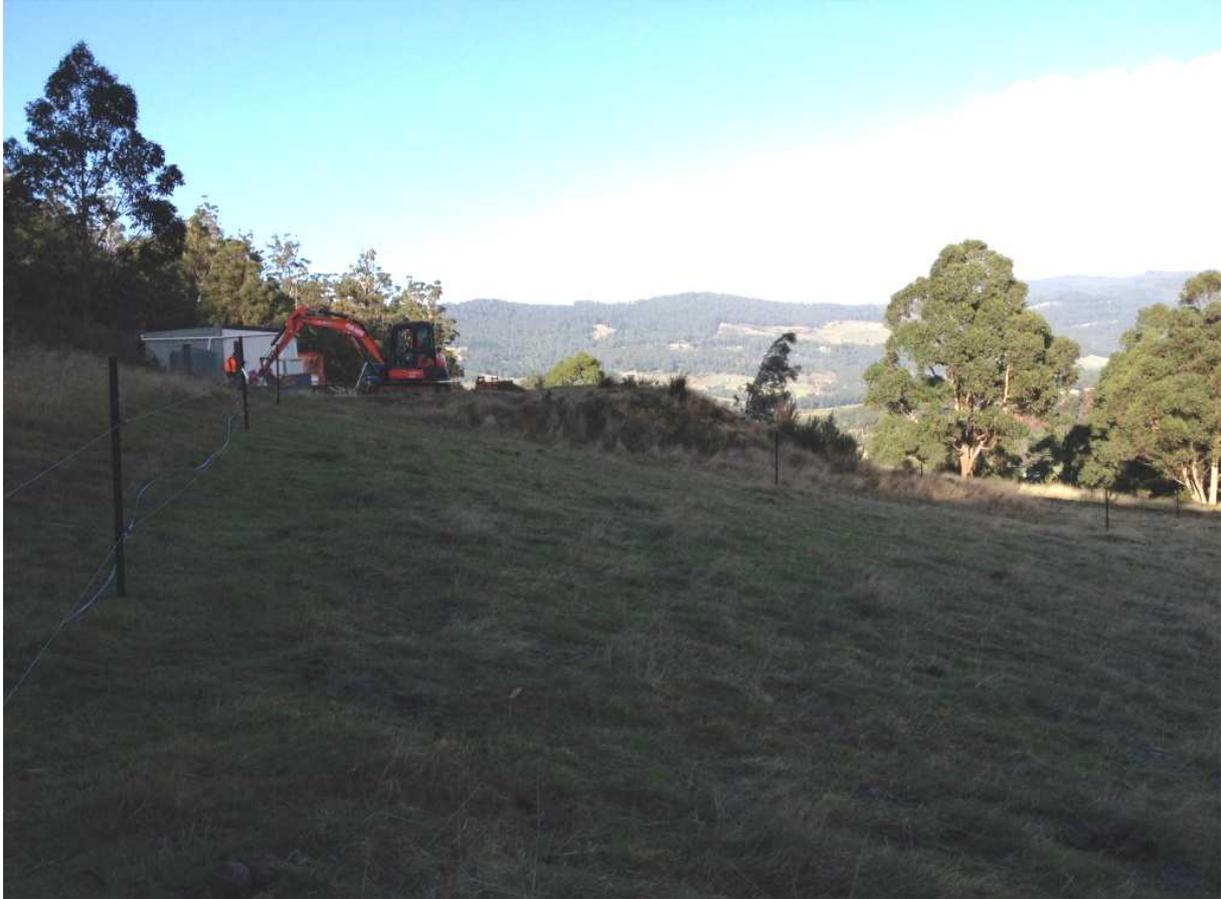
Plate 5 (above). View south and cross-slope towards the pad for the house, showing the (presumably uncontrolled) fill from the excavation placed by a previous owner. The slopes in the foreground are flattening from 12 – 10°.

Fill has been placed as a (presumably) uncontrolled wedge of soil and weathered bedrock at the house site, where it forms an outer embankment several metres high. Topsoil from the excavation has been placed at the base of the embankment.

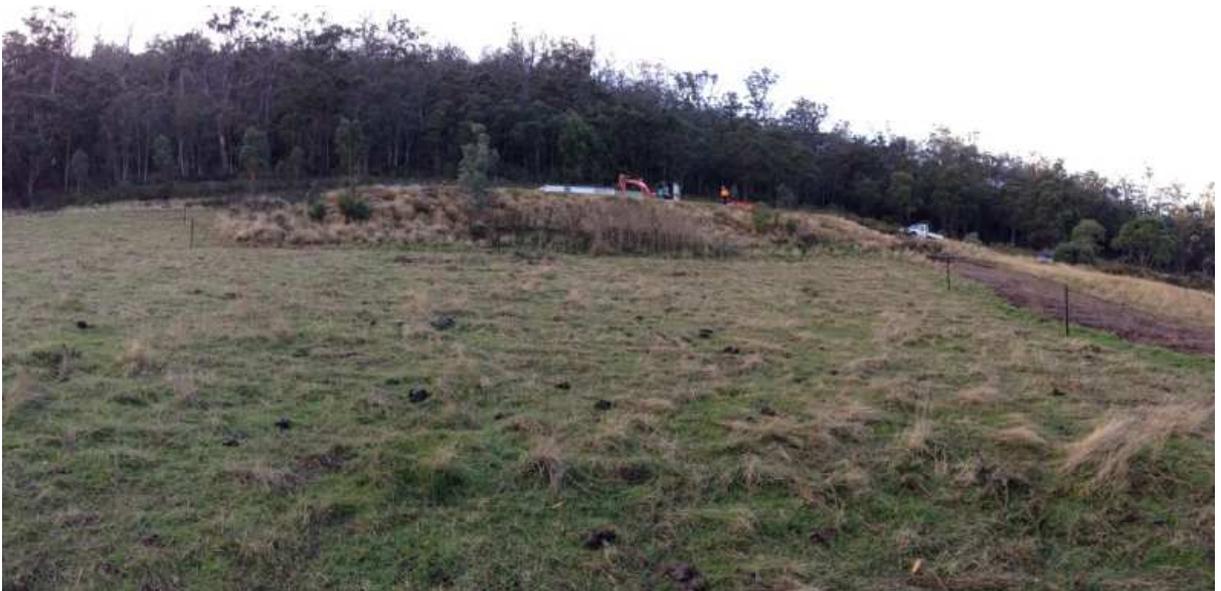
Plate 6 (below). Panoramic (distorted) view west and upslope towards the house site. The access drive is at right.

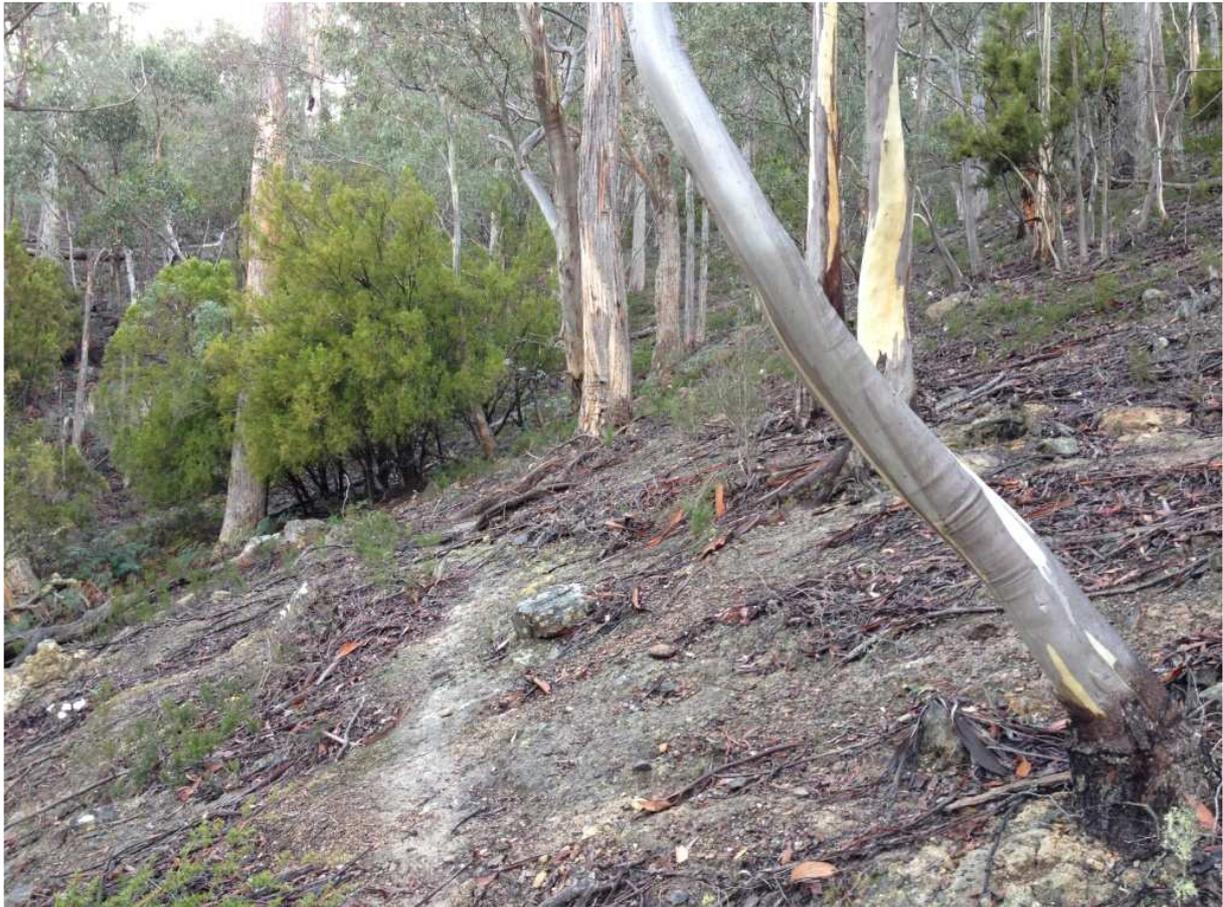
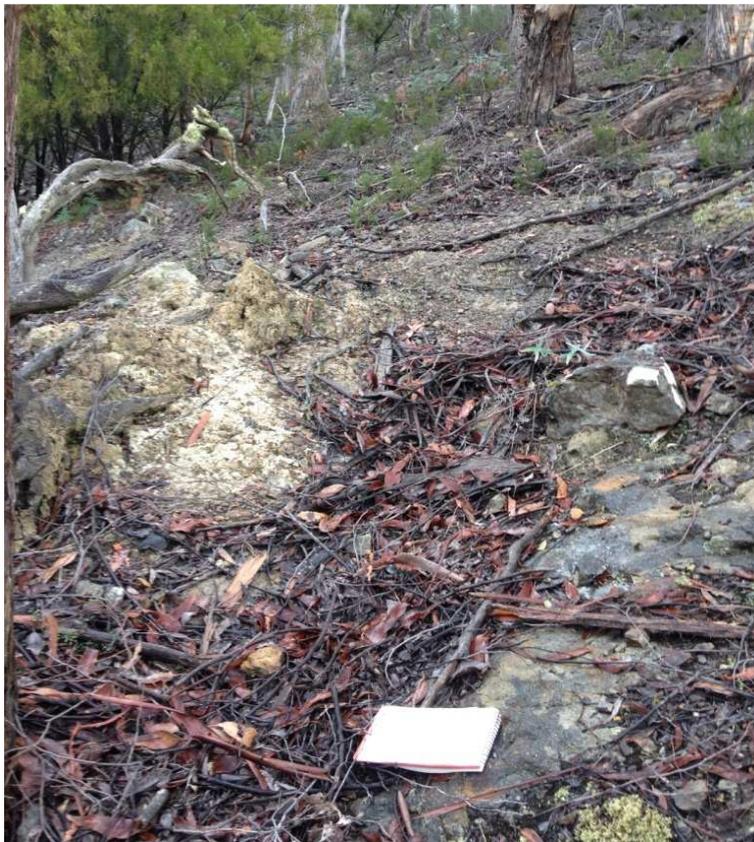
Plates 7 (above) and 8 (left). Hillside slopes are in the 30 – 35° range above the house site, and comprise thin light coloured gravelly sandy silt soils on Permian age-bedrock. Bedrock or subcrop is common on the slopes.

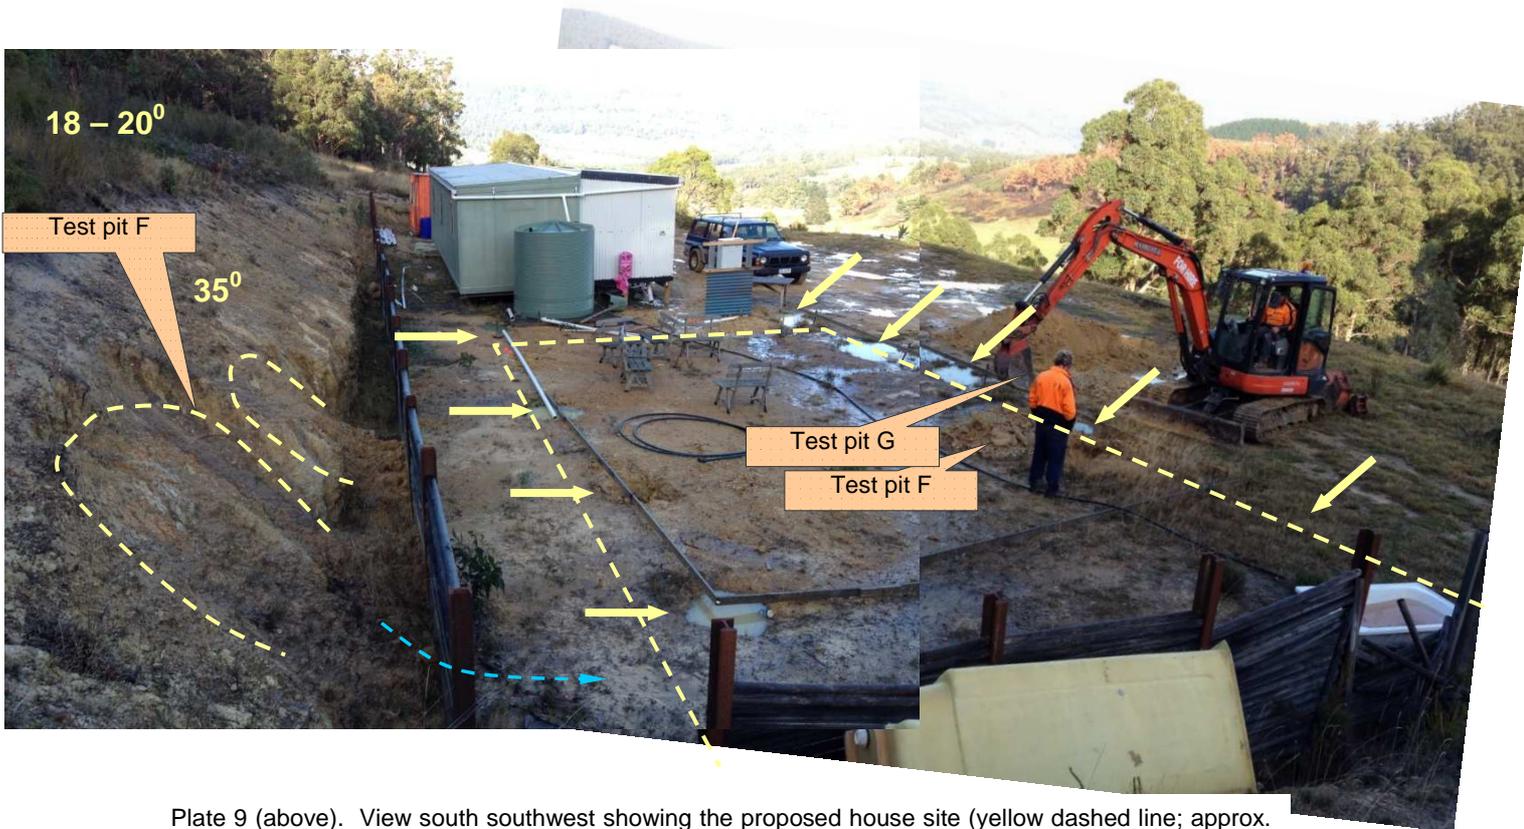
Plate 9 (above). View south southwest showing the proposed house site (yellow dashed line; approx. only), previously-dug auger holes for piers (arrowed), test pits F and G, the steel-posted and undrained timber retaining wall (blue dashed line shows water flow), the 35° batter slope behind, and two very small rotational landslides on the batter face.

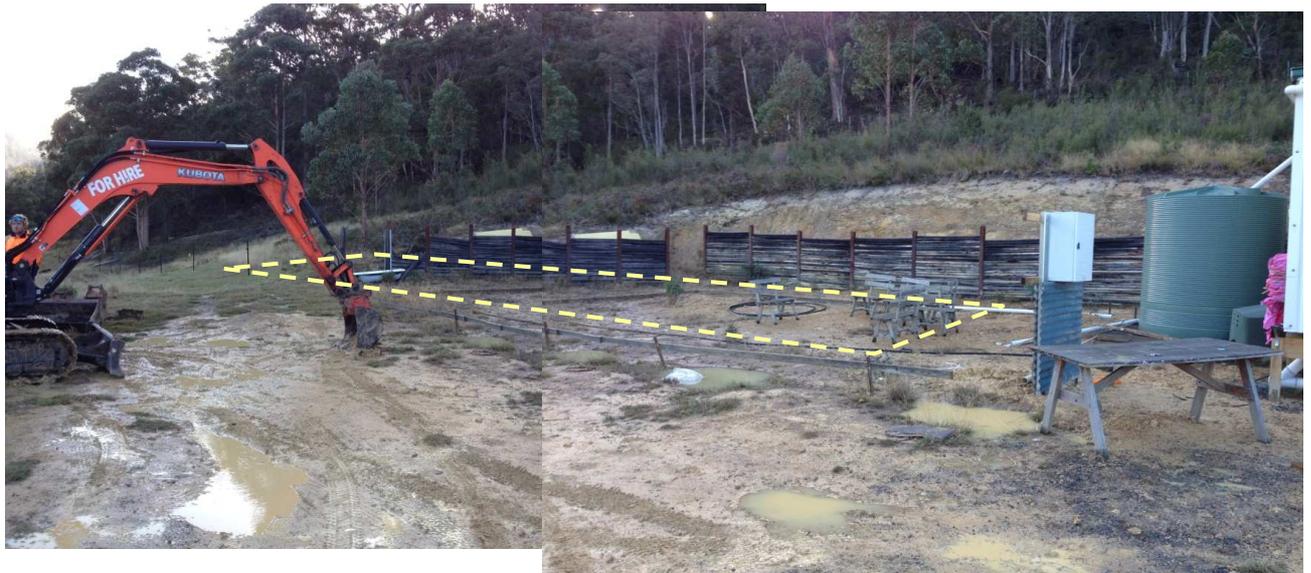
Plate 10 (below). View northeast towards the proposed house site (yellow dashed line; approx.). The excavator is digging test pit G.

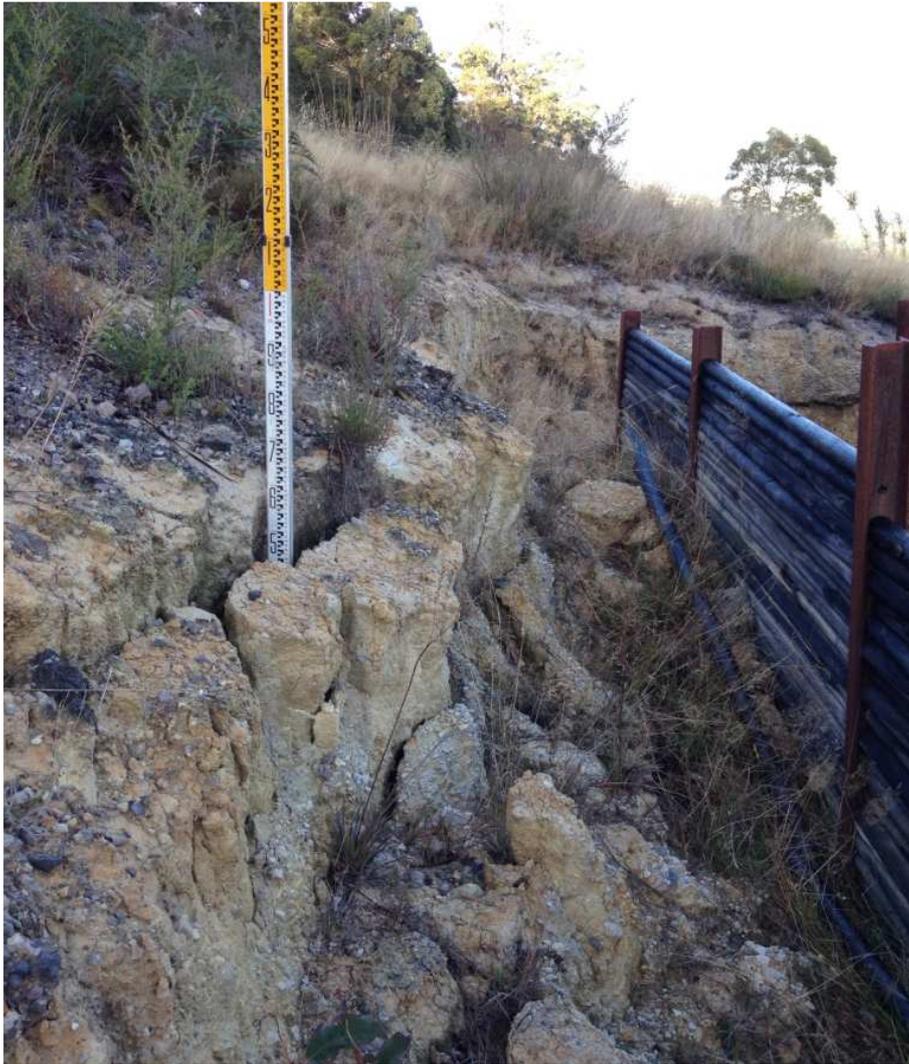
Plate 11 (above). View south at very small-scale rotational landsliding in colluvial soils at the southern end of the timber retaining wall.

- The excavation by a previous owner for the house site has created slopes of around 30 – 35° in an oversteepened cut to the east, and an uncontrolled fill embankment to the west (Attachment 2). Very small scale rotational landsliding has occurred on the oversteepened cut, and the failed material has been adequately retained by a 1.8m high wall.

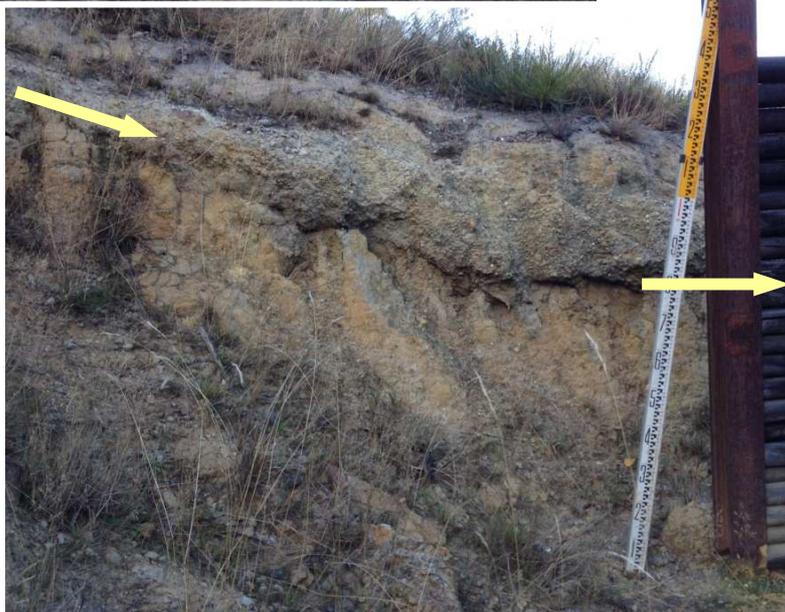
Plate 12 (right). View south at the end of the timber retaining wall, showing the northern side of the small shallow translational landslide (activity unknown) identified in Plate 2. Colluvial soil has slid (slowly?) over similar materials. The staff is about 1.6m long.

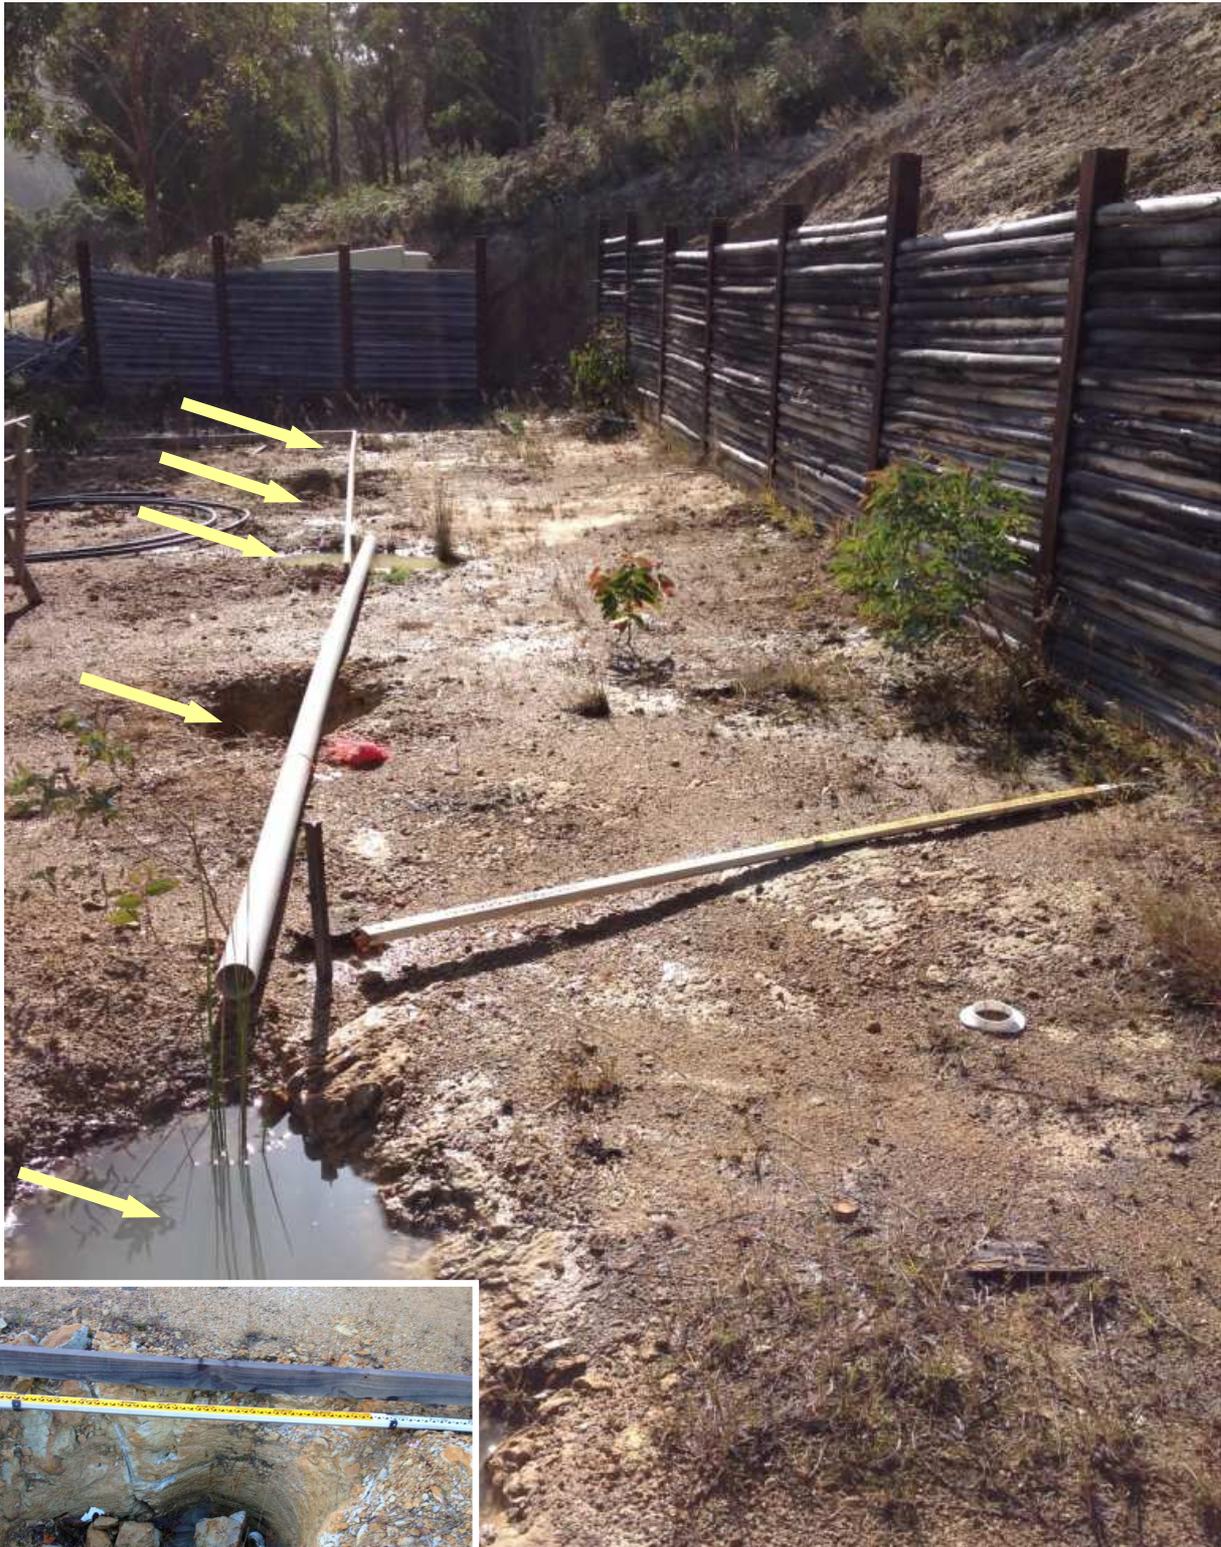
Plate 13 (above). View north across the eastern side of the house excavation prepared by a previous owner. The staff is 2m long. The five arrowed pier holes, each about 0.5m in diameter and ranging from 0.3 to 0.5m deep, were excavated in highly weathered Permian sandstone bedrock (inset at left). Bedrock is exposed over most of the foreground in this photo.

I recommend all piers be extended into sandstone bedrock, at various stages of weathering. Along the eastern side of the house footprint, highly weathered but adequately competent bedrock is at or within about 0.3m of the excavated surface.

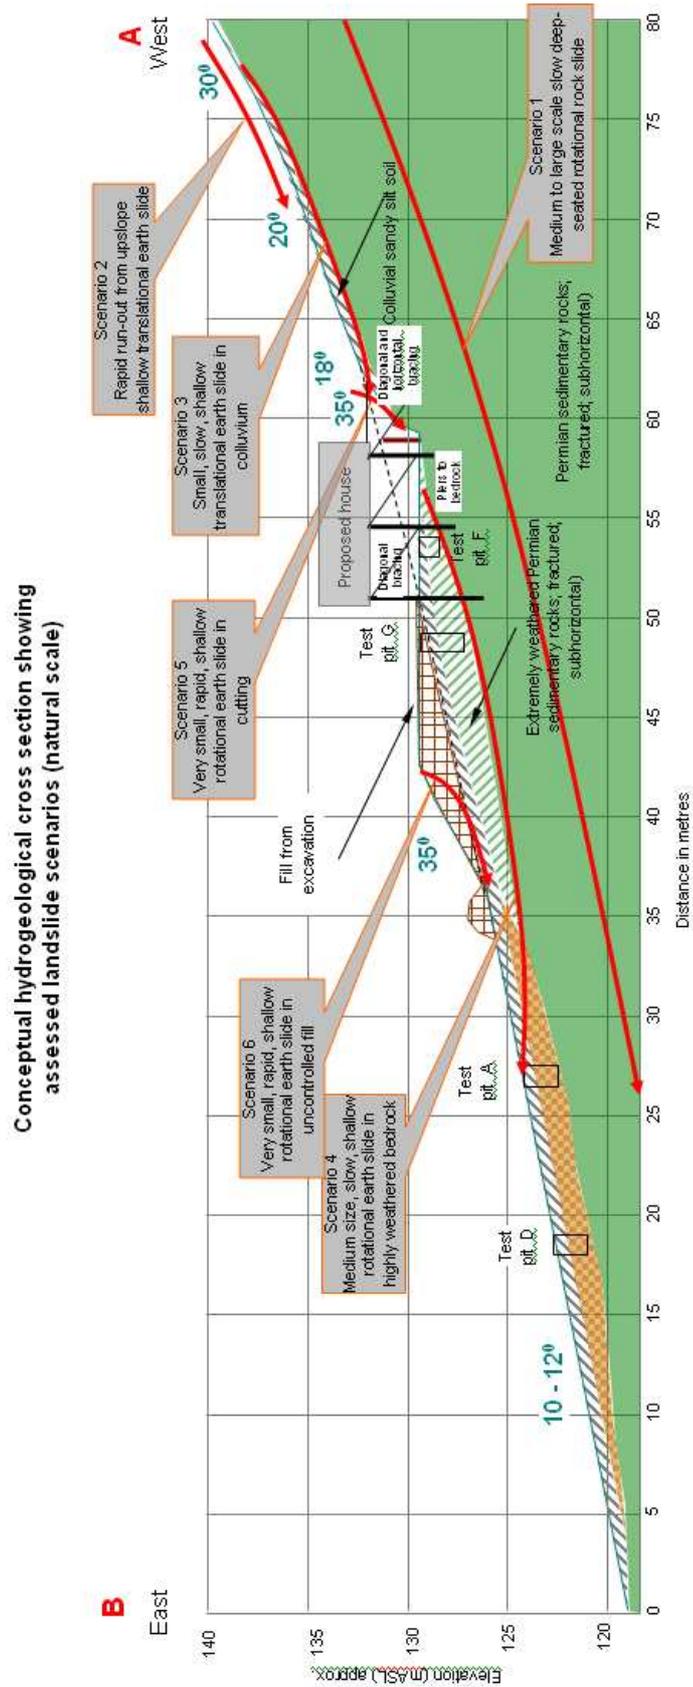
Figure 5.2 Interpreted cross section through proposed house site (natural scale), showing landslide scenarios 1 – 6 addressed in this Attachment. See Attachment 4 for location of the section line.

Risks for scenarios #4 and 6 after development have been reduced from Moderate to Low (highlighted in red in Table 5.4.) by house construction methods, and the probability of reducing water infiltration into the uncontrolled fill near the house site.

To mitigate the potential consequences of small scale shallow landsliding at and above the site (Scenario 5 in Attachment 5), and beneath the house site (Scenario 4), the house piers should be adequately founded (see below) and braced to each other. Similar braces shall be extended into the battered slope, or the slope above the batter, or both, to offer further lateral support and mitigation of Scenario 3. A suitably experienced engineer shall certify the design.
