WILLIAM C. CROMER PTY. LTD.

ECoast Homes Pty Ltd

**PROPOSED 76 – LOT SUBDIVISION
PENQUITE ROAD, NEWSTEAD**

GEOTECHNICAL ASSESSMENT

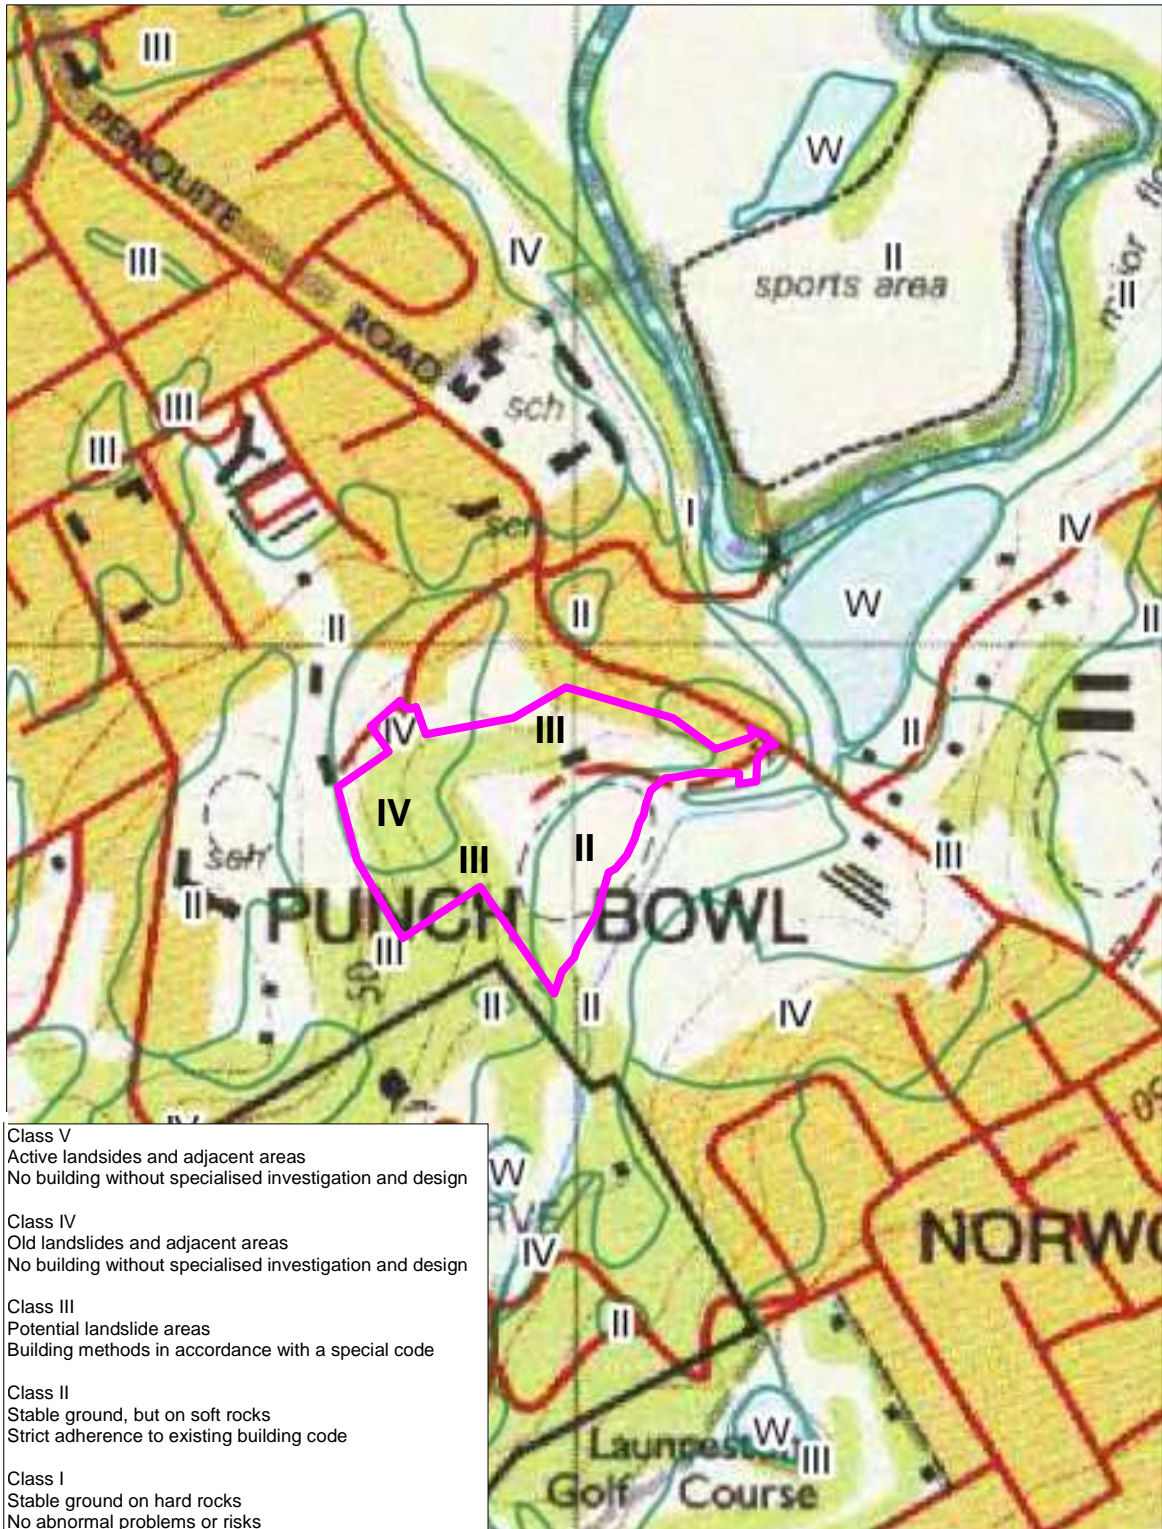
The flat ground on the former Eastman Oval is Class II. Steeper ground to the north and west is Class III. Still steeper and higher ground near the western boundary is Class IV.

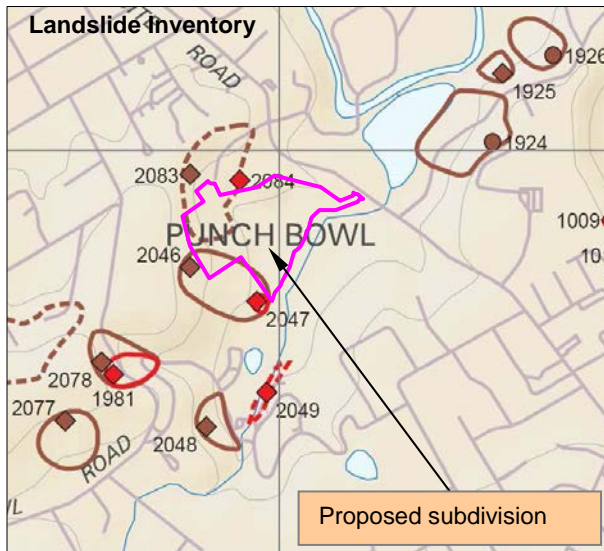
The southwestern corner of the proposed subdivision overlaps part of a “fossil or old dormant” landslide, within which are two landslide points: point 2046 (regarded as a fossil old or dormant shallow landslide), and 2047, shown as a recent or active shallow landslide. The northwestern part of the proposal is included in a fossil old or dormant Landslide Zone (the position of which is approximate) with fossil (2083) and recent (2084) shallow landslides. In the general vicinity are several other fossil old or dormant landslides and old or dormant, and active, shallow landslides. For a more detailed discussion of slope stability issues, see Attachment 9.

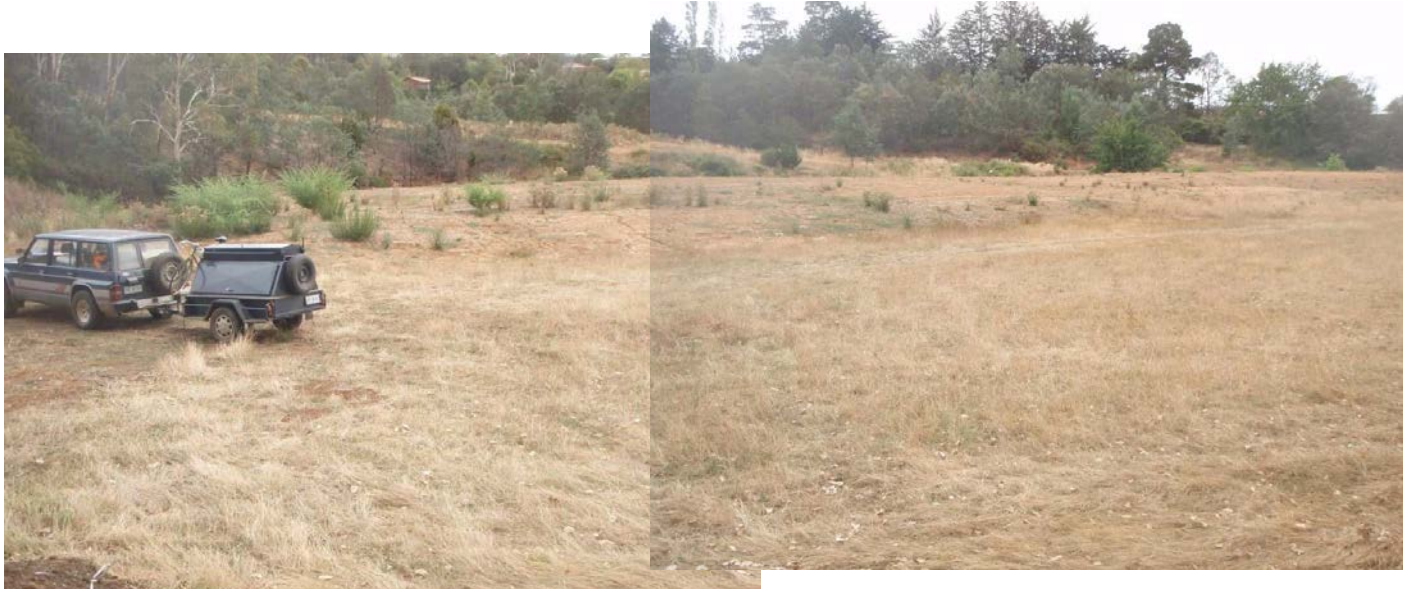
Plate 1 (above). View looking northwest over the former Eastman Oval showing a low, raised mound of fill in the middle ground, separated from the steep embankment behind by a depression. The embankment probably represents the edge of a former channel of Kings Meadows Rivulet. The foreground is also a thin layer of fill over alluvial sediments.

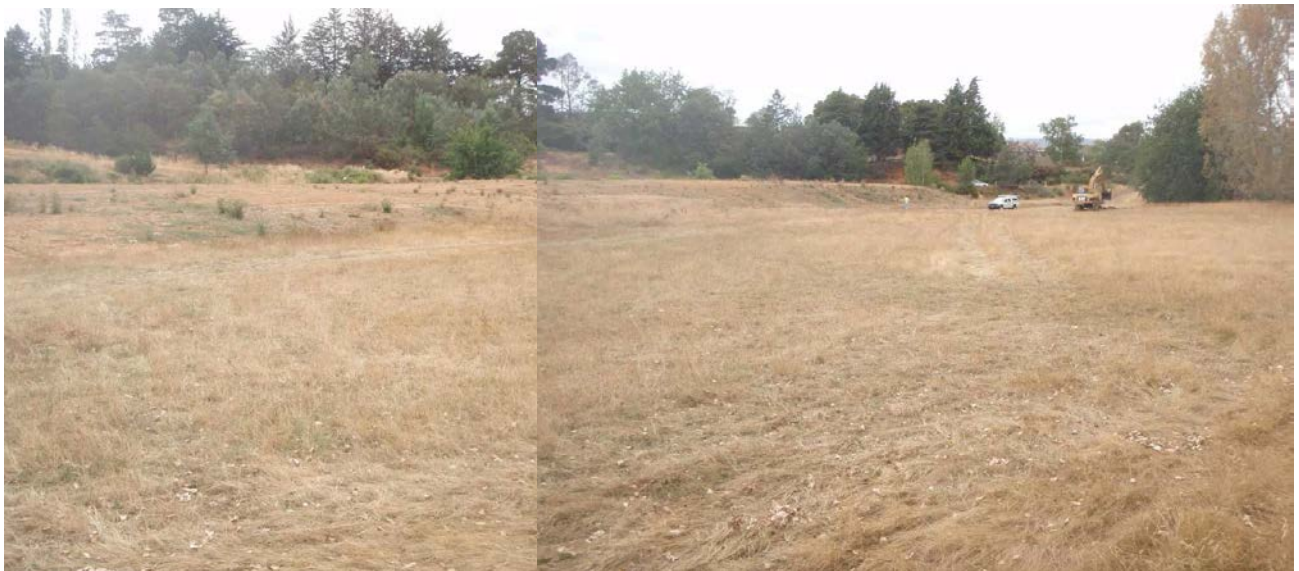
Plate 2 (below). A view similar to Plate 1, looking north. The excavator is digging test pit J. Most of the foreground will be raised a metre or more, and a metre or more taken off the mound, to create building allotments.

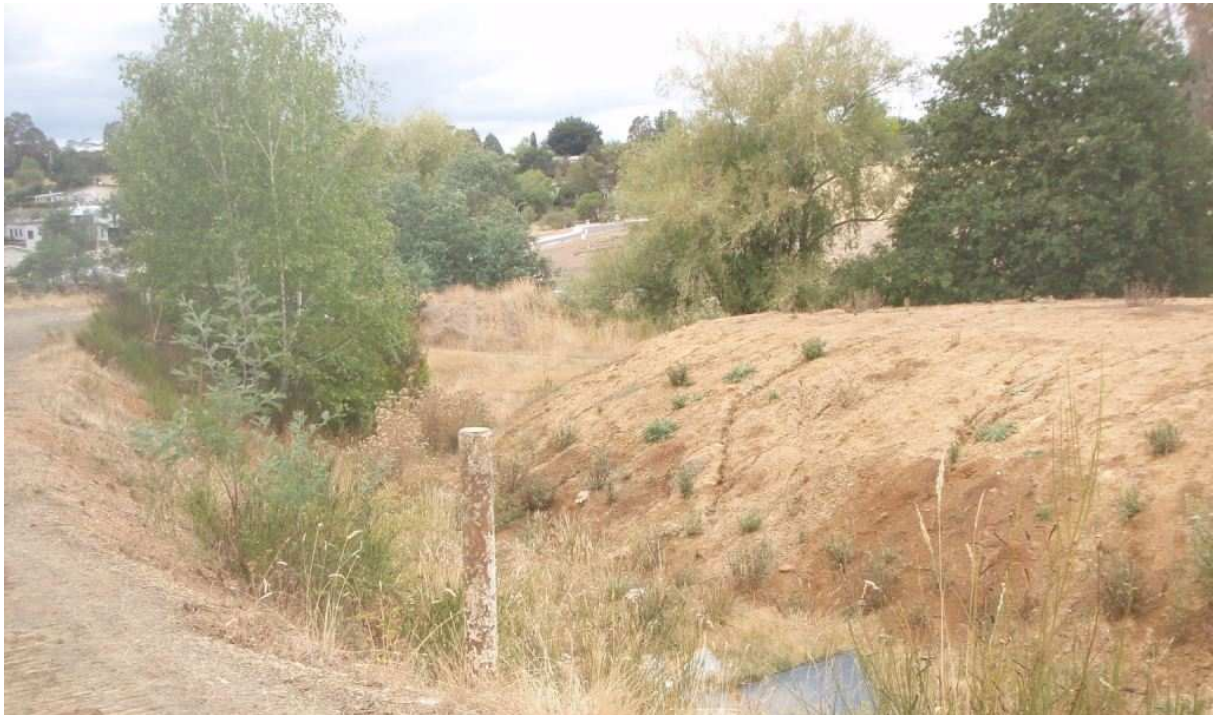
Plate 3 (above). View looking east showing raised fill at right on the former Eastman Oval, and the embankment at left.

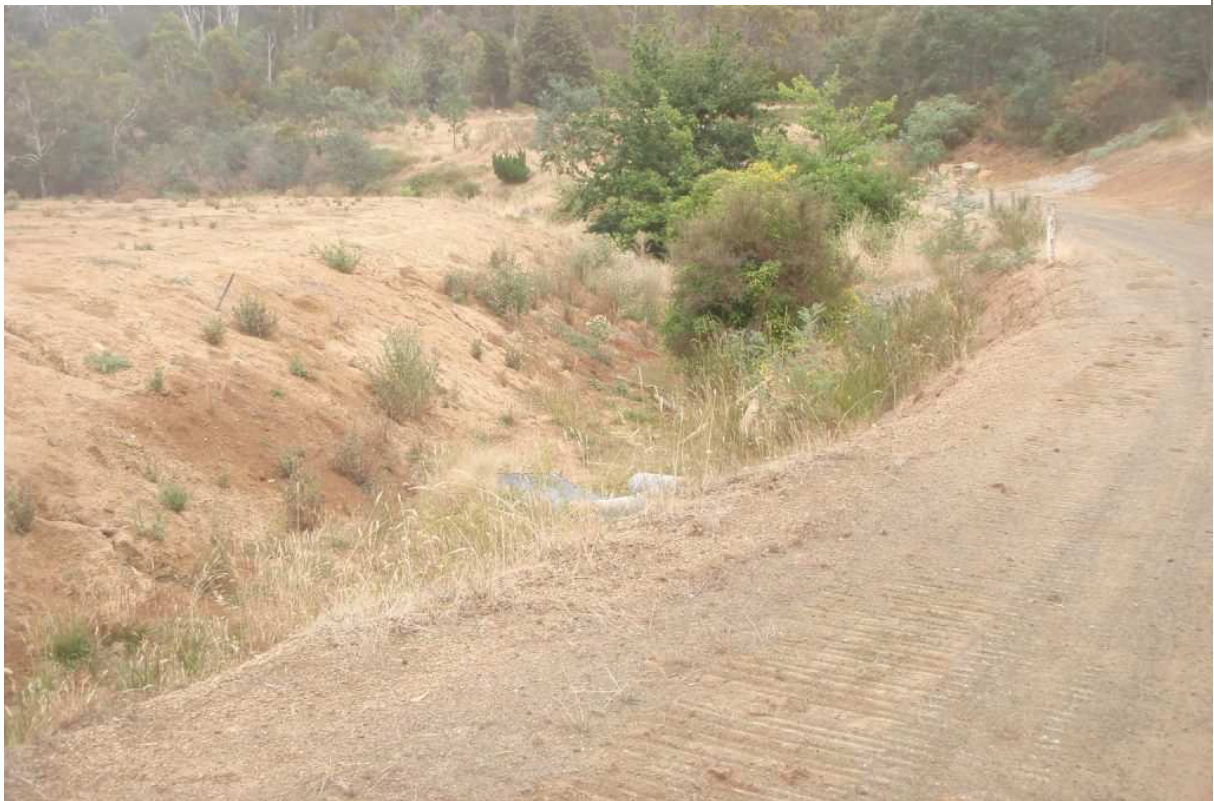
Plate 4 (below). Looking west from the same point as Plate 3. The raised fill is up to about 3 – 3.5m thick. The depression between it and the embankment will be filled in, and some of the mound removed, to create building allotments.

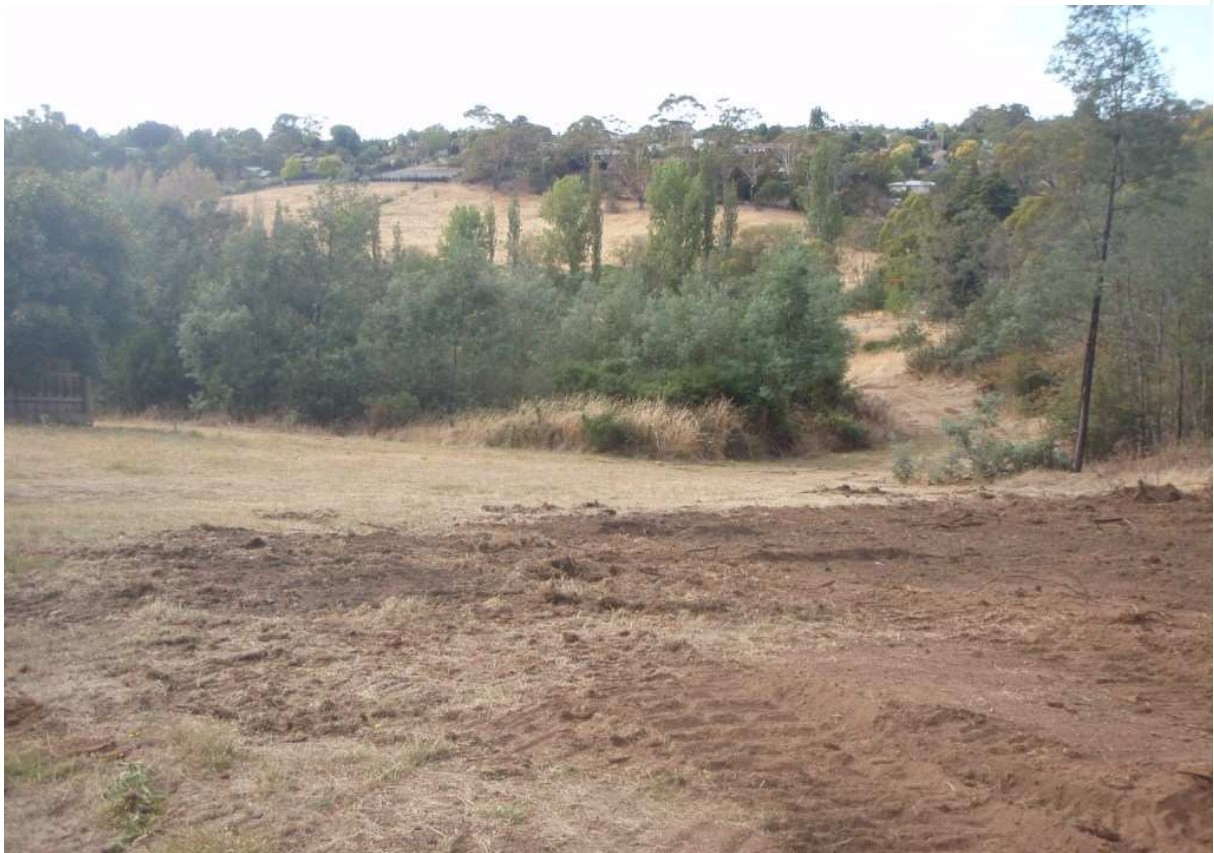
Plate 7 (above). View looking east over dumped piles of inert fill (bitumen, concrete, soil) on the slope east of pit I.

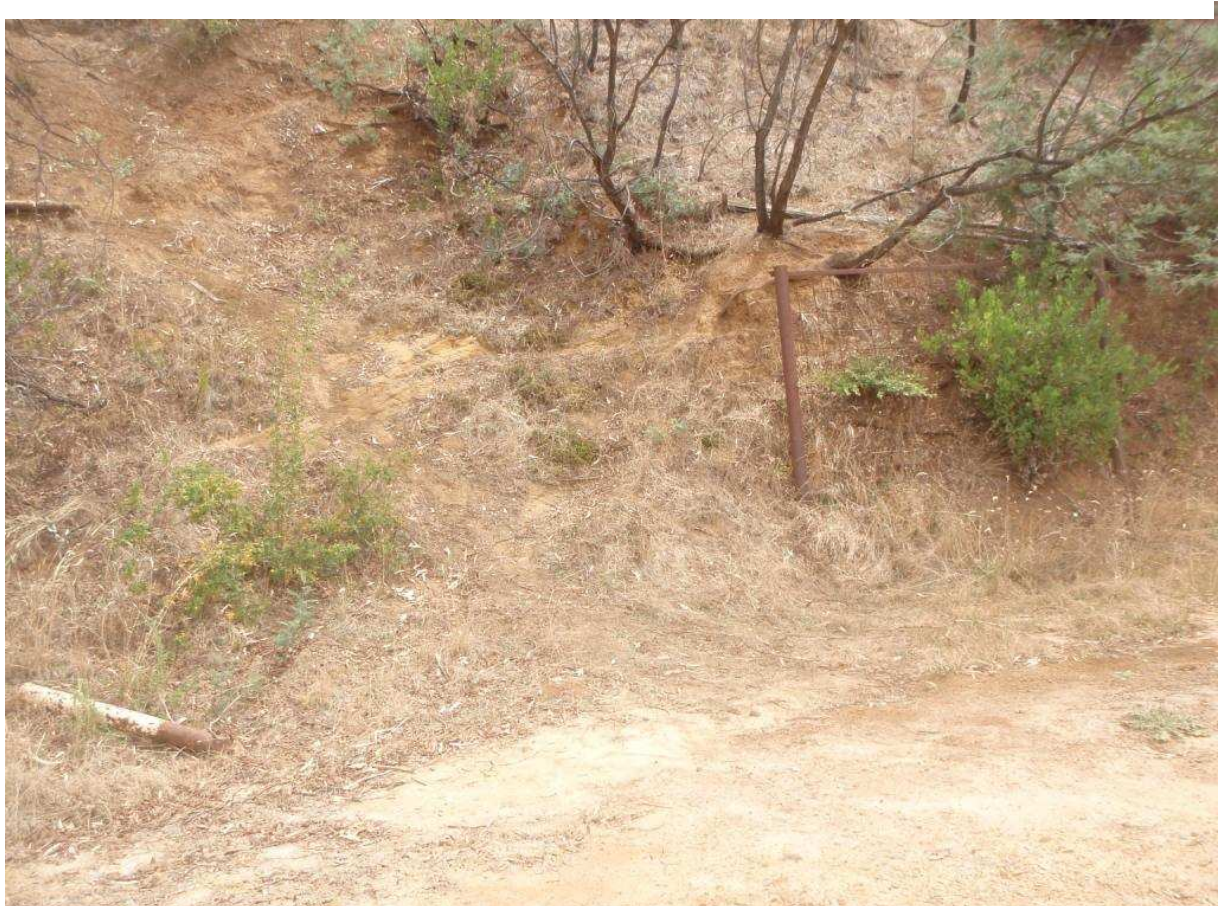
Plate 13. Test pit A exposed lateritic conglomerate (top; orange and light yellow) over dark grey mudstone (bottom). Further digging exposed sandstone under the mudstone. All materials are interpreted as Tertiary in age.

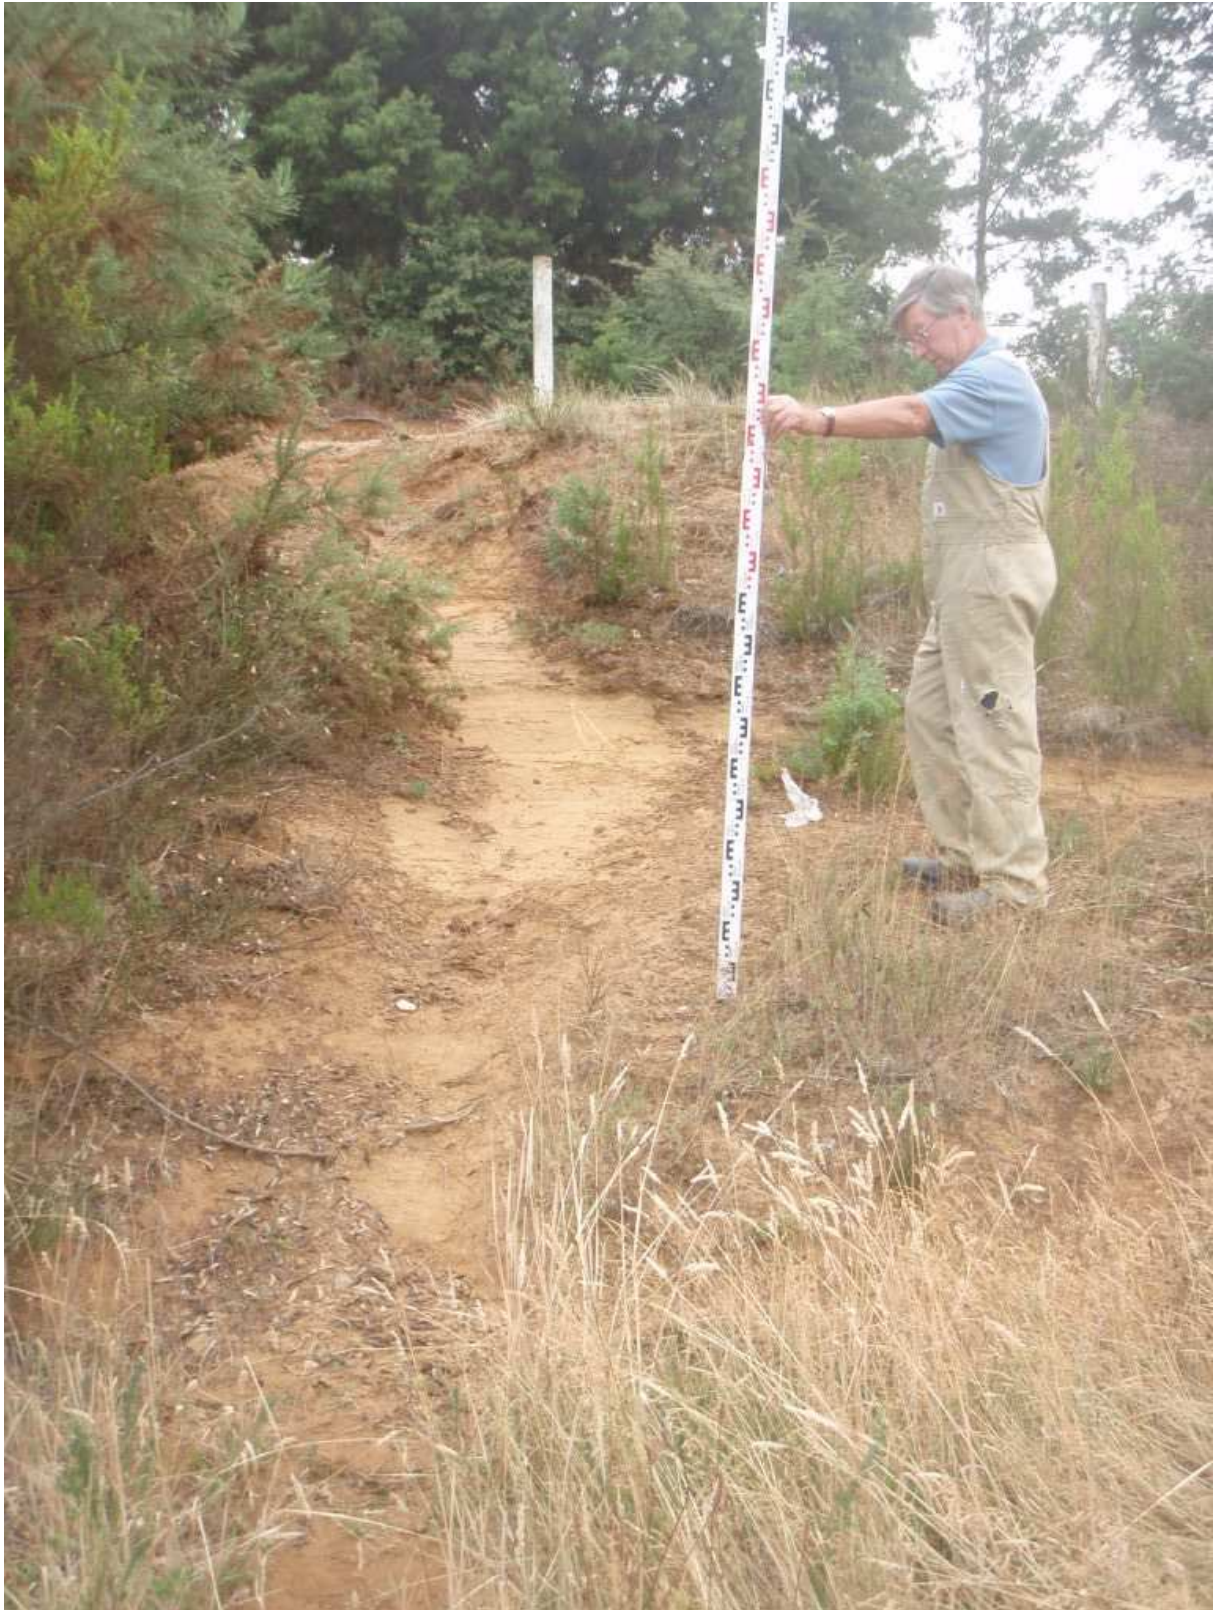
Plate 15. Tertiary sandstone exposed on the embankment beside the access road, about 35-40m NNE of test pit .1

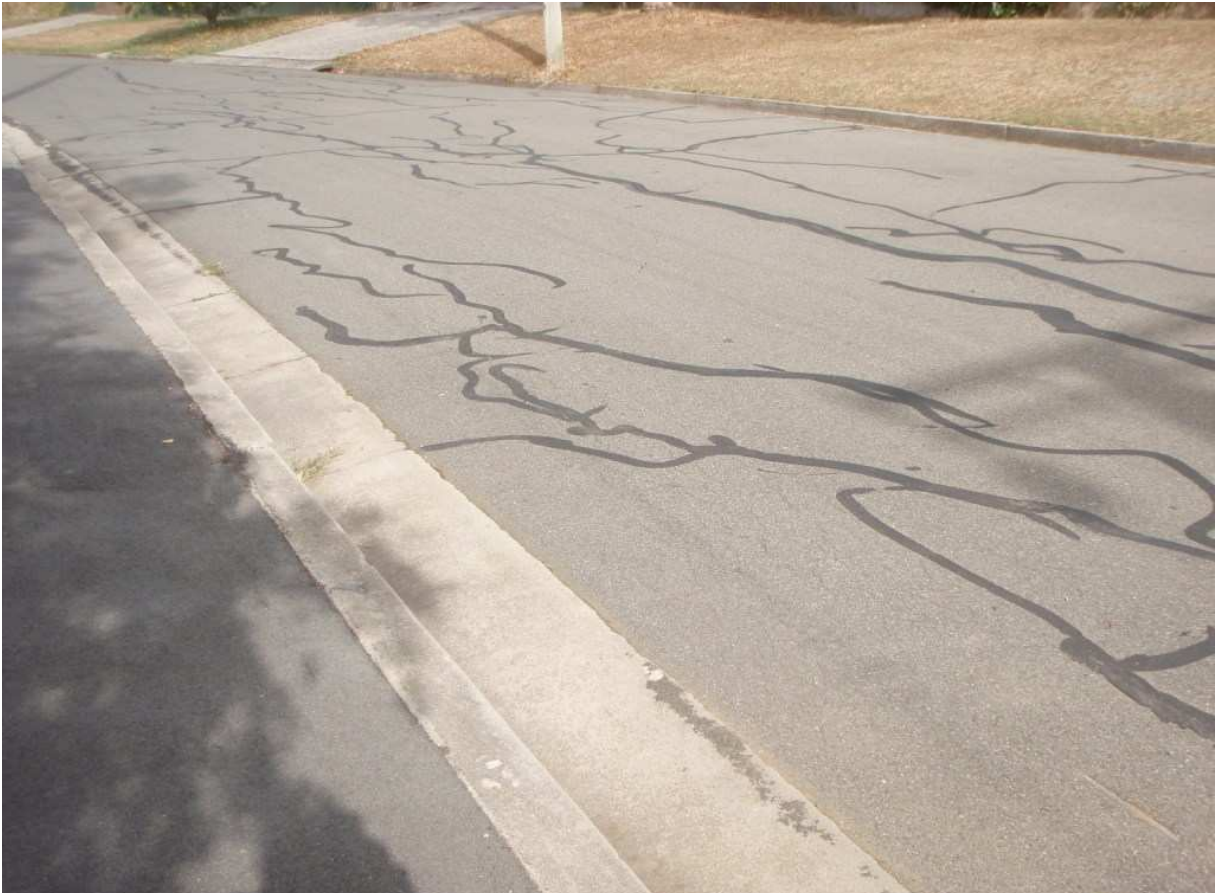
Plate 16 (above). Repaired cracking of bitumen in Thelma Street, which may have been caused by soil movement.

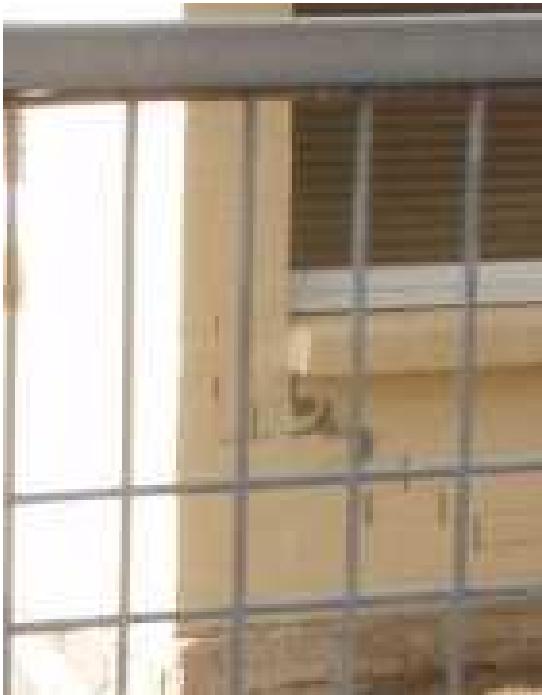
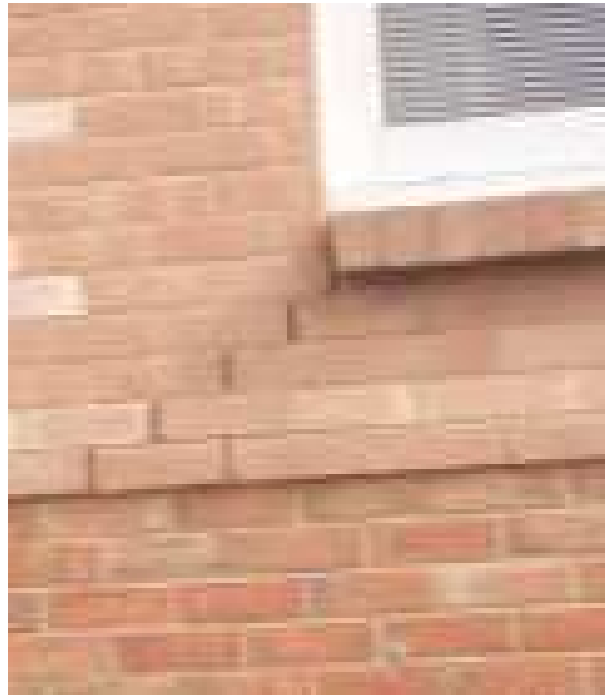
There is no evidence of current slope instability, and no reports of house damage due to slope instability in the area. Damage to houses in the district (Plates 16 – 20 in Attachment 9, and MRT records and reports) is thought to be due to reactive clay soils.

Plate 17 (below). Damage to houses in Thelma Street and Penquite Road probably caused by footing movement on reactive clay soils.

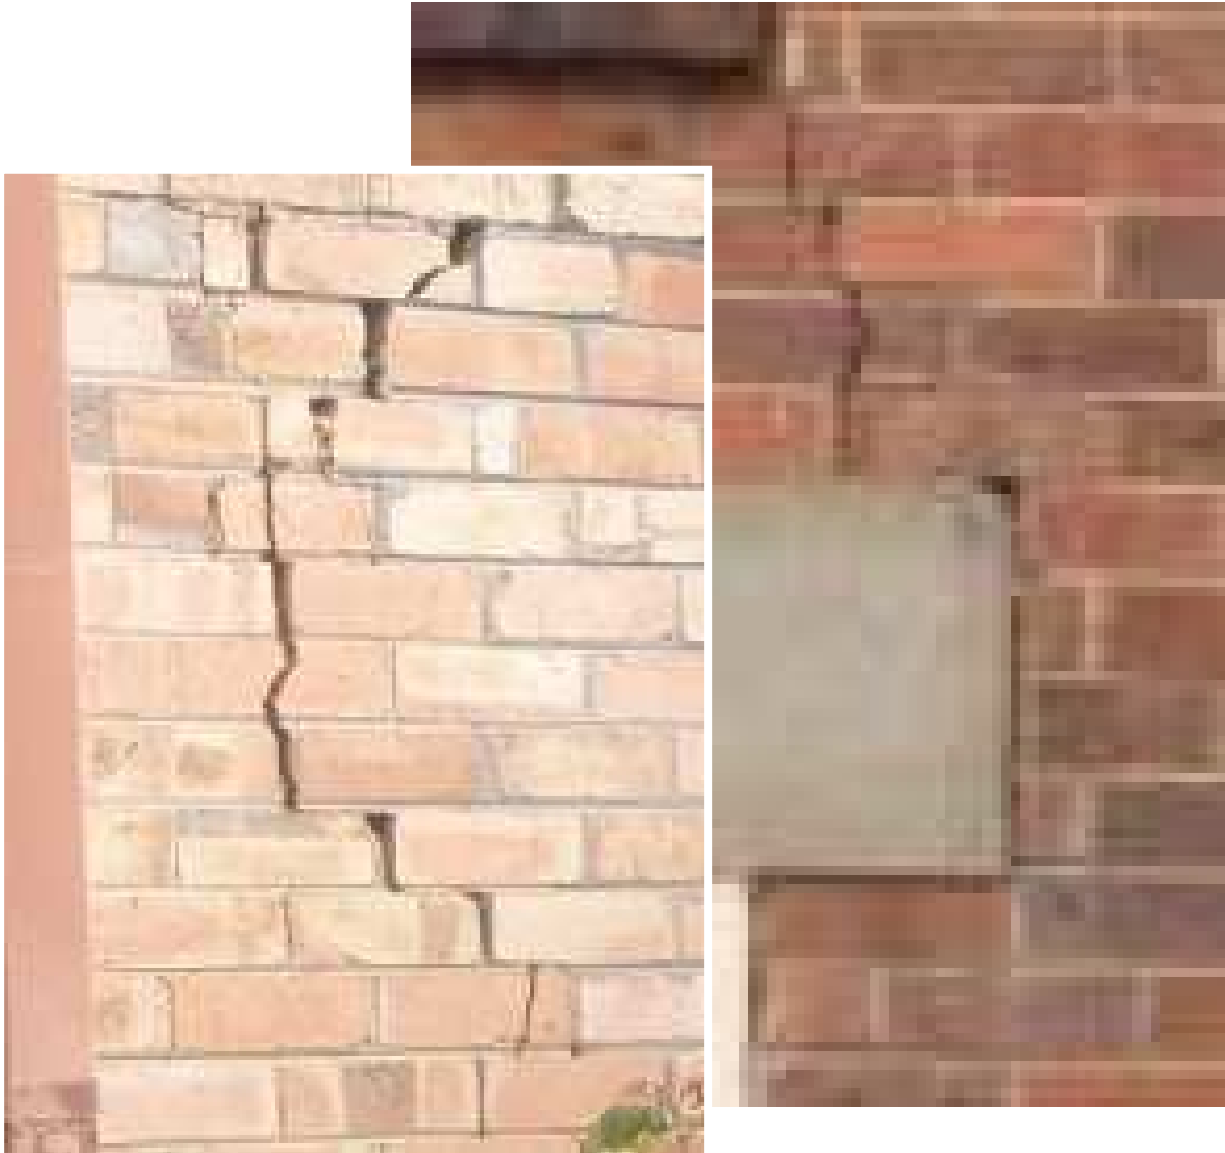
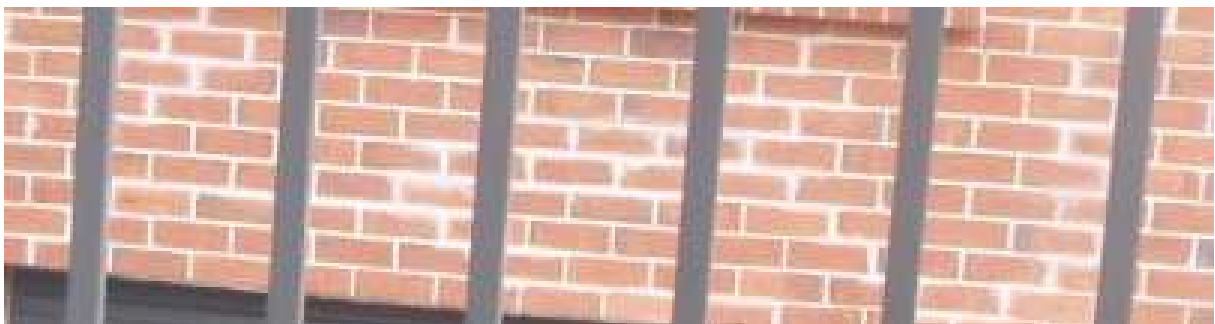
Plates 18, 19 and 20. Damage to houses in Penquite Road probably caused by footing movement on reactive clay soils.
