PROPOSED NEW HOUSE 110 AYRES ROAD RANELAGH

GEOTECHNICAL SUMMARY

Municipality
Client
Location
Development
Date of inspection

Huon Valley
I and J Urquhart
110 Ayres Road, Kettering
New house
6 May 2014

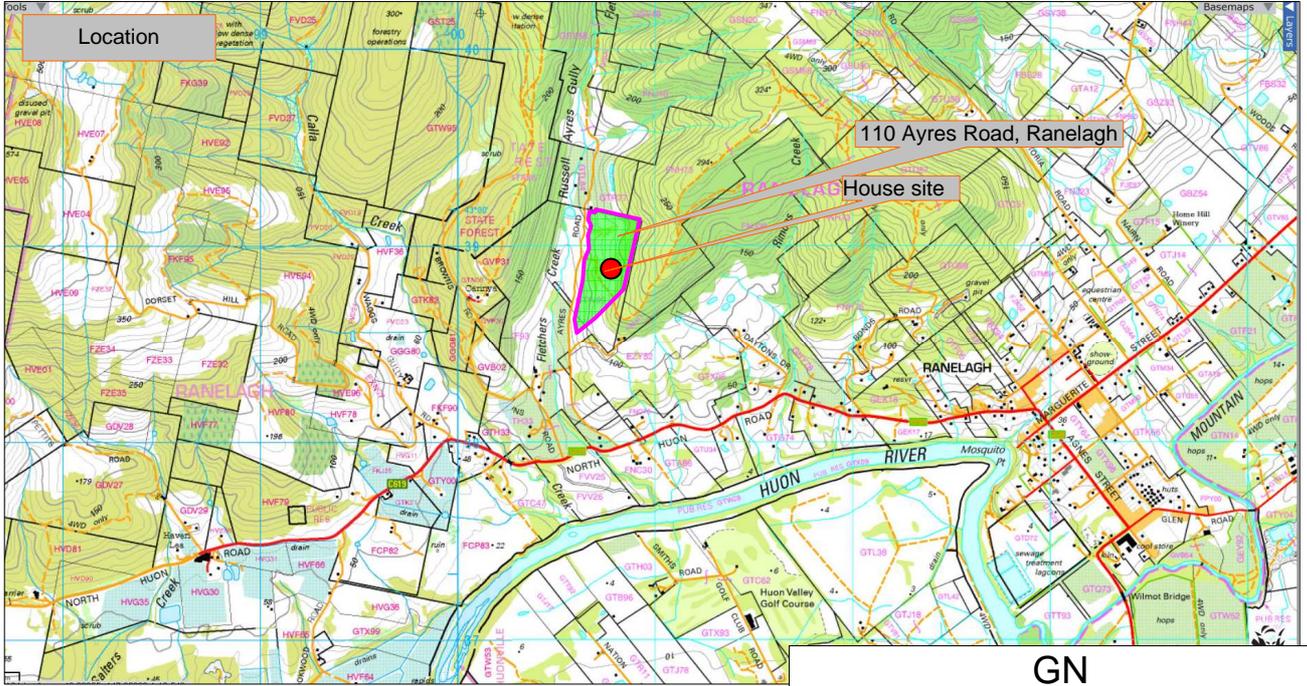
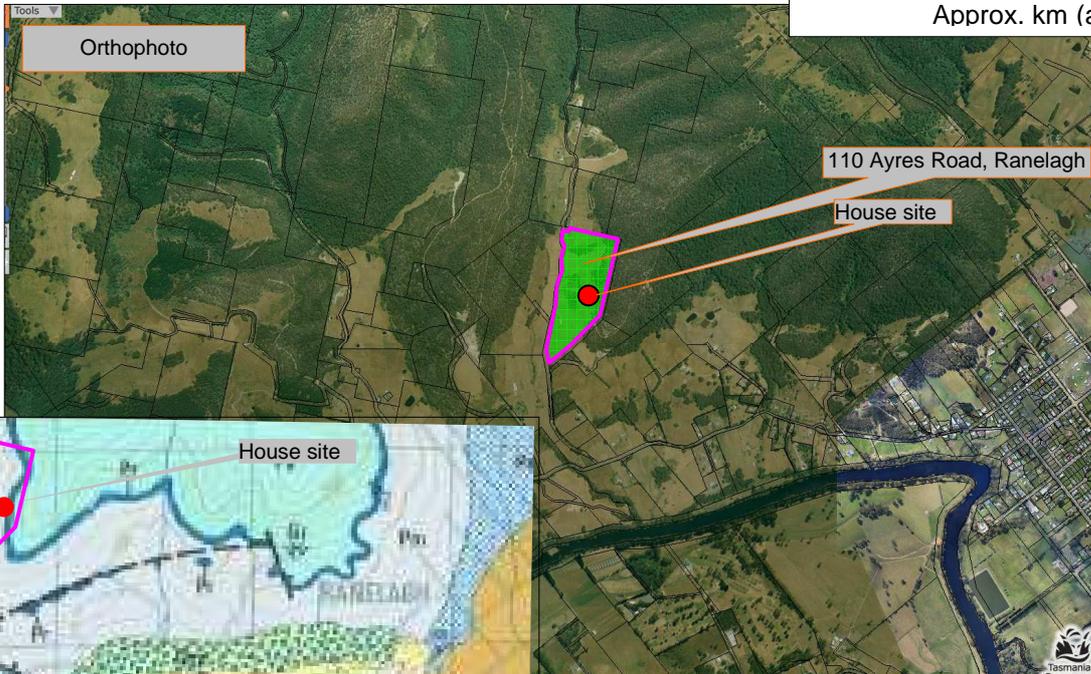
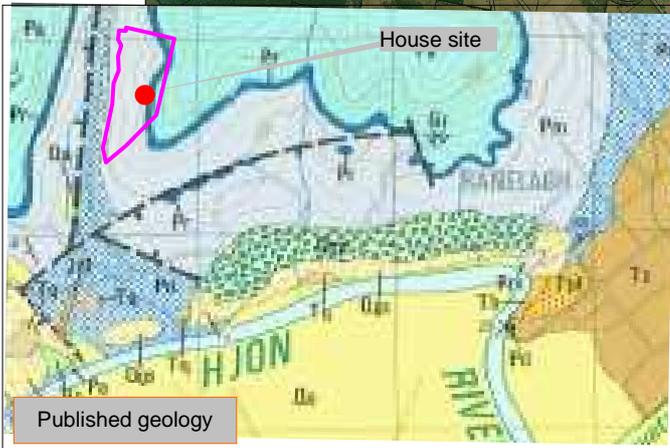
Location, aerial imagery, published geology and landslide hazard bands

The house site and surrounds are in the Low Landslide Hazard band, but a Medium band exists quite close on the steeper ground to the east.

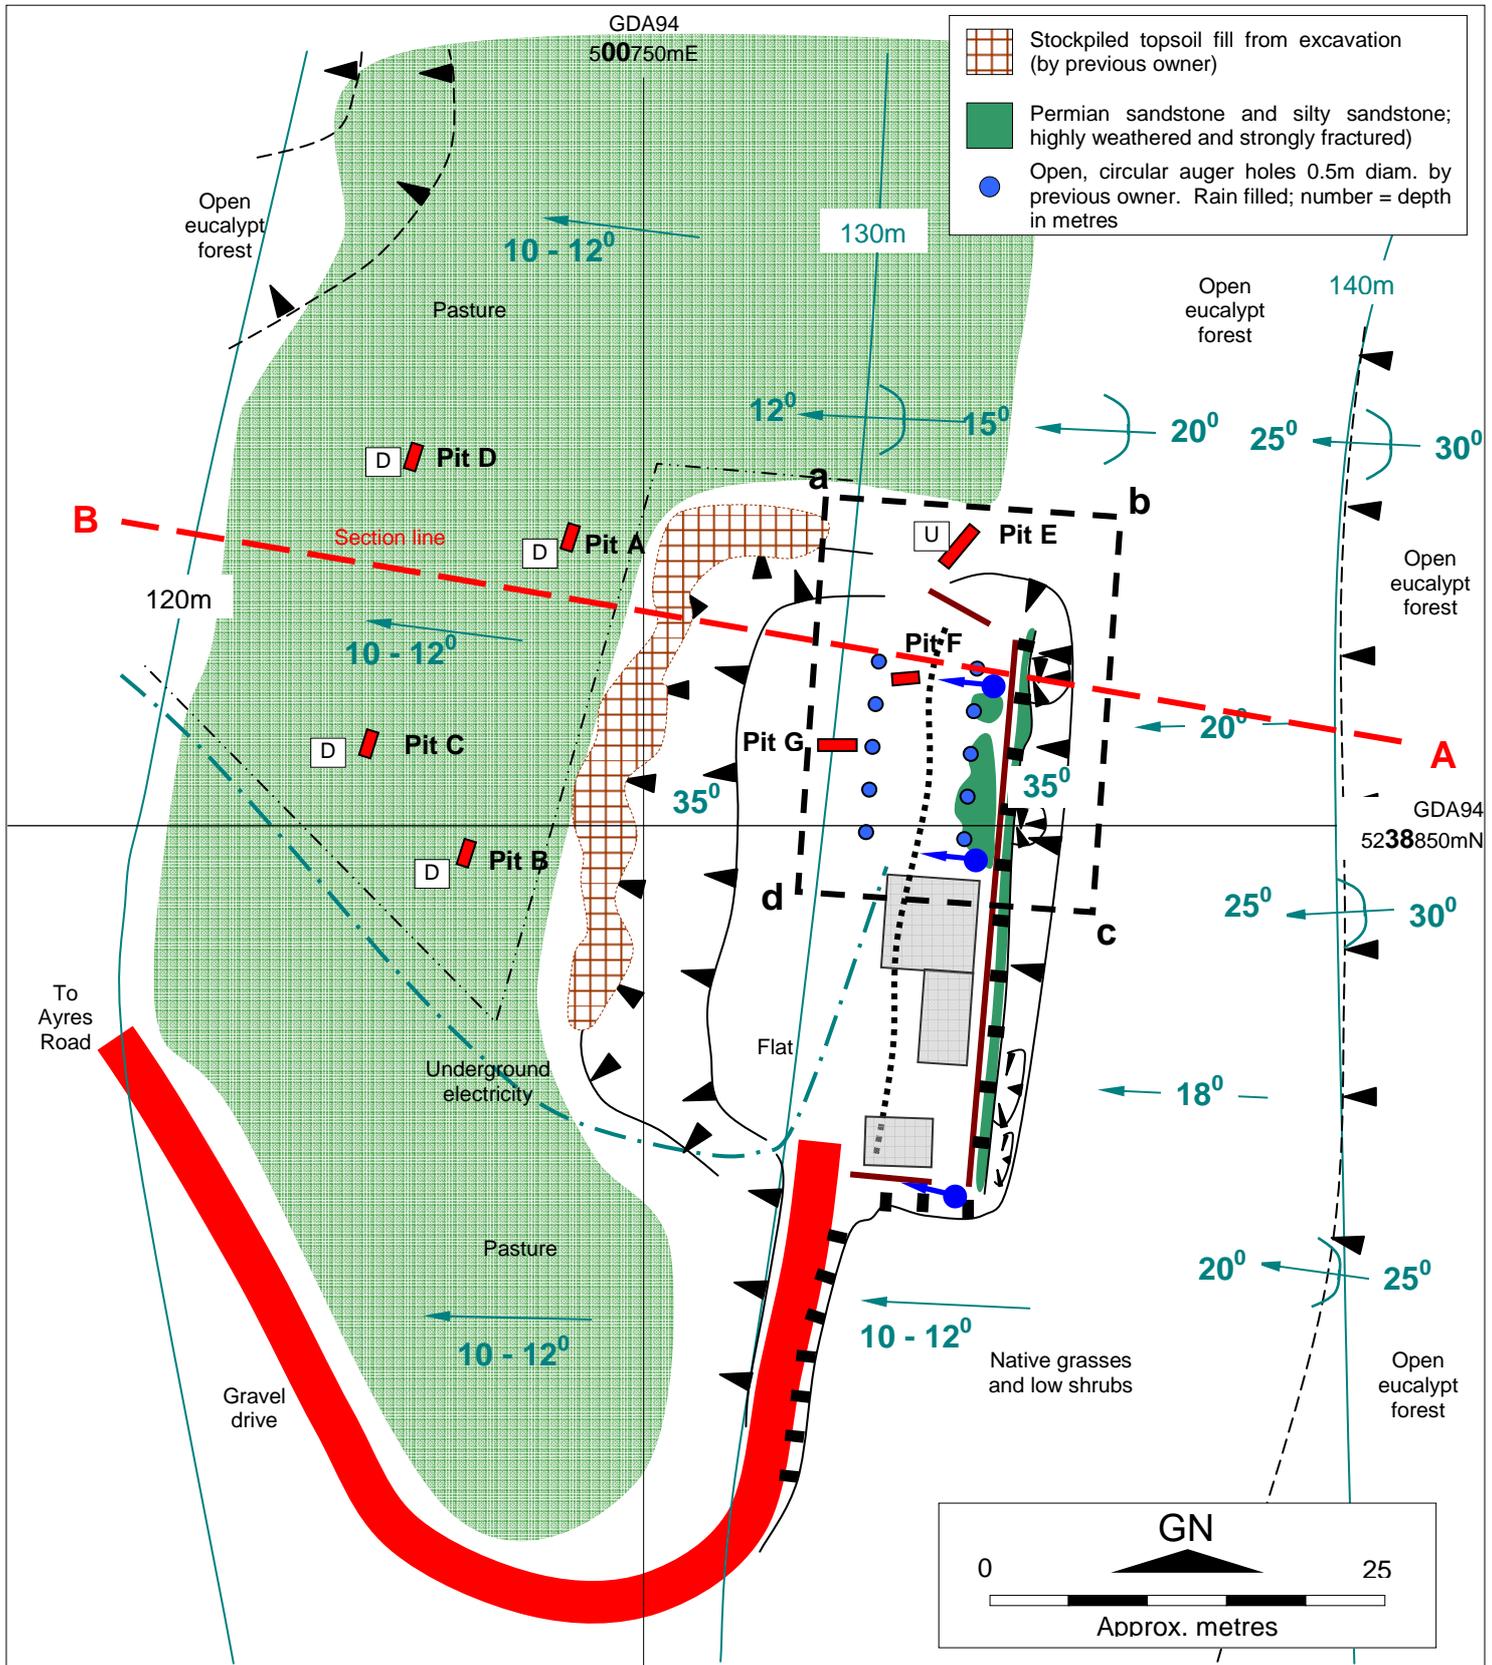
Attachment 2
 (2 pages)
Site sketch showing test pit locations and the area abcd
to which the AS2870 site classification refers

- The excavation by a previous owner for the house site has created slopes of around 30 – 35° in an oversteepened cut to the east, and an uncontrolled fill embankment to the west (Attachment 2). Very small scale rotational landsliding has occurred on the oversteepened cut, and the failed material has been adequately retained by a 1.8m high wall.

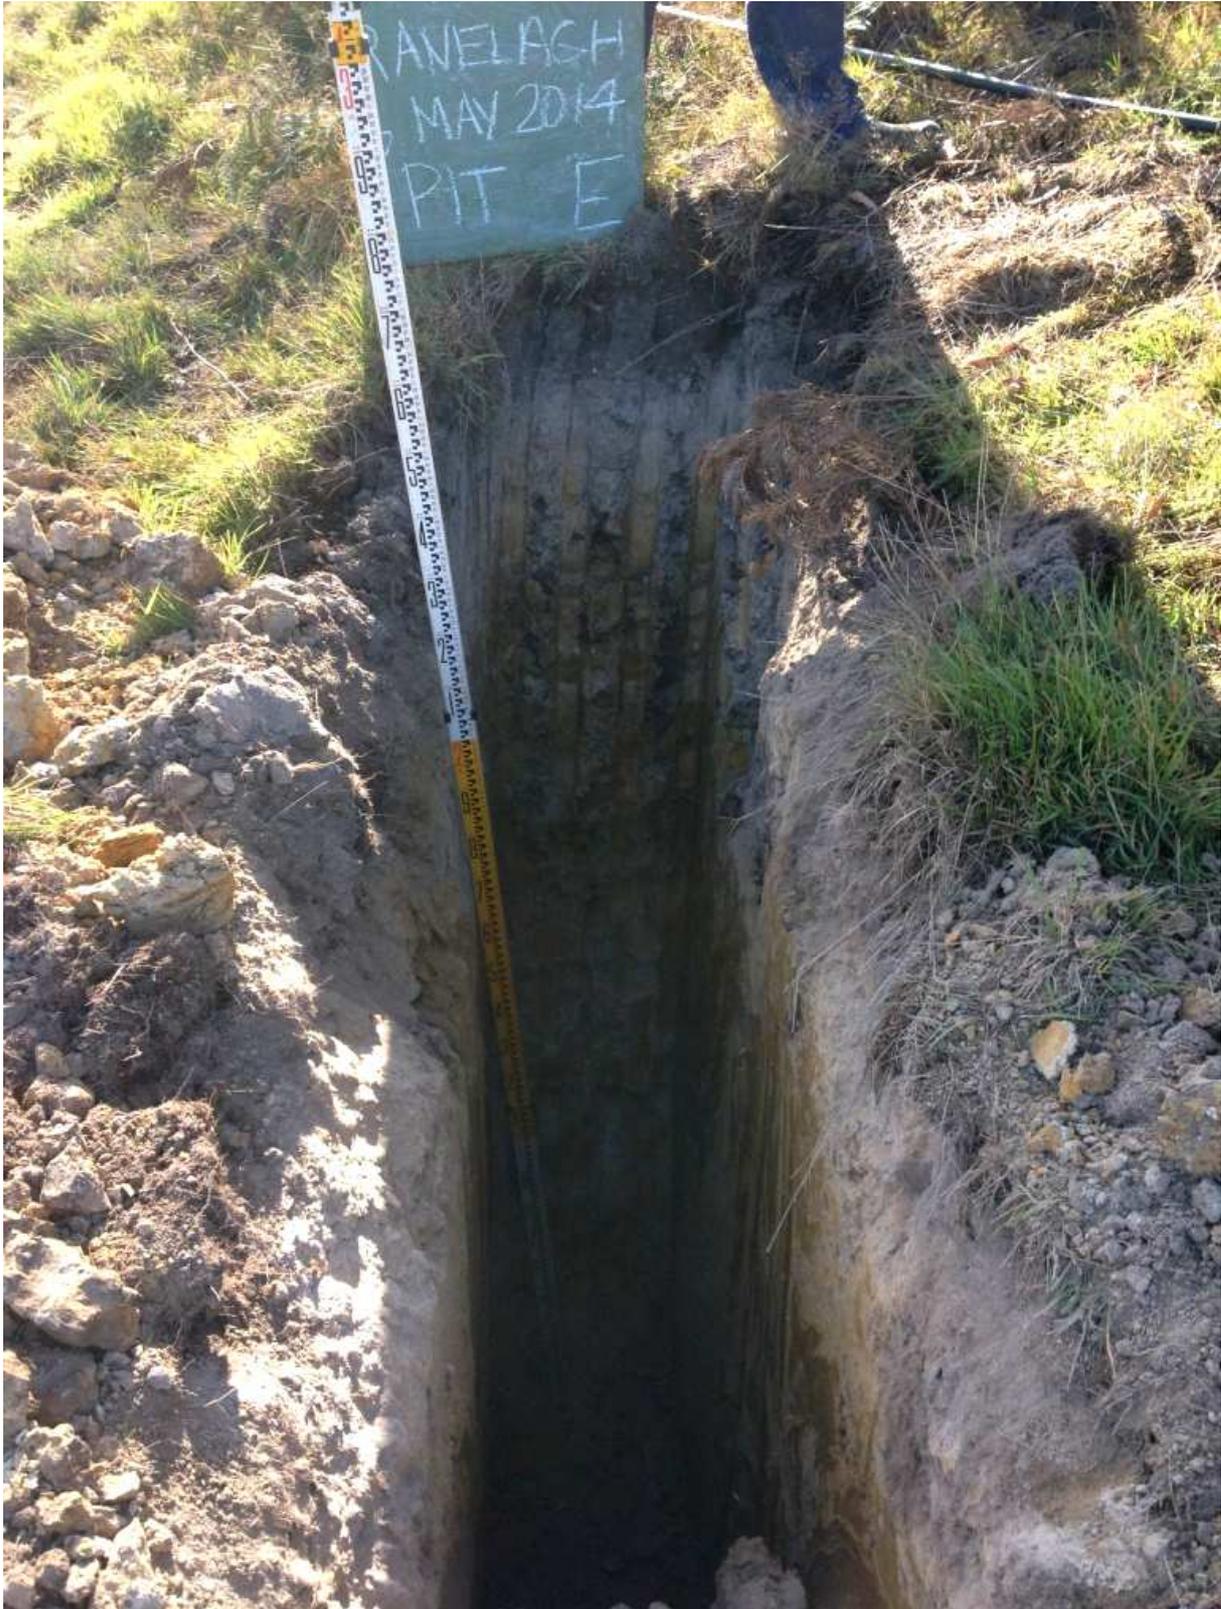
In the following photos of test pit profiles, the staff is graduated in metre long yellow and white segments. The numbers are decimetres (tenths of a metre).

mainly highly to extremely weathered in test pits, the excavation at the rear of the house site, and in previously augered pier holes.
