WILLIAM C. CROMER PTY. LTD.

ECoast Homes Pty Ltd

**PROPOSED 76 – LOT SUBDIVISION
PENQUITE ROAD, NEWSTEAD**

GEOTECHNICAL ASSESSMENT

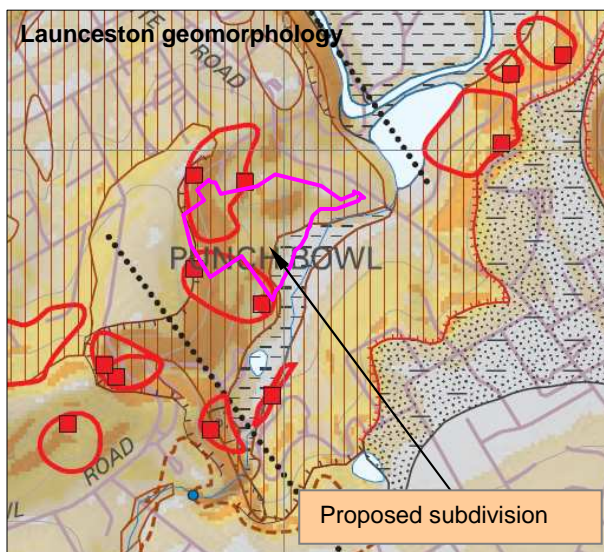
Most of the proposed subdivision is mapped as “Younger slopes on Tertiary sediments”, with slope angles mainly in the range 7 – 13°, and smaller slope segments (particularly in the west) in the 13 – 35° range. The floor of Kings Meadows Rivulet is mapped as a flood plain.

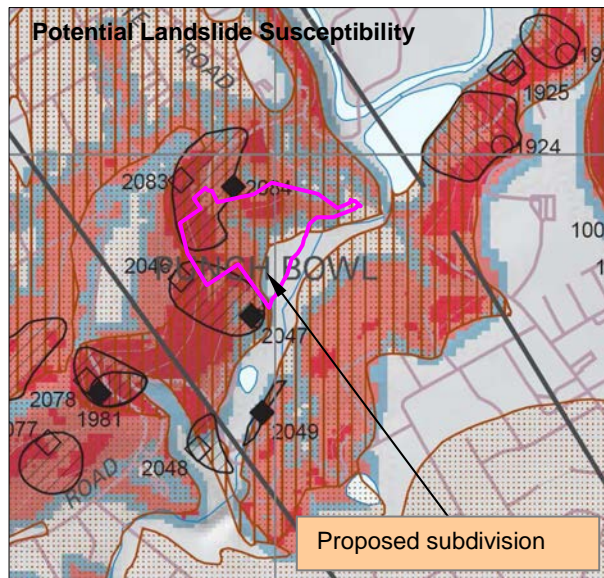
Map 5. Potential Landslide Hazard

All of the proposed subdivision mapped as “Younger slopes on Tertiary sediments” in Map 2 is regarded as susceptible to landslides. The probability of landsliding increases as the slope angle increases, so the parts of the proposal most susceptible are along the western and northern sides. The balance is a buffer zone.

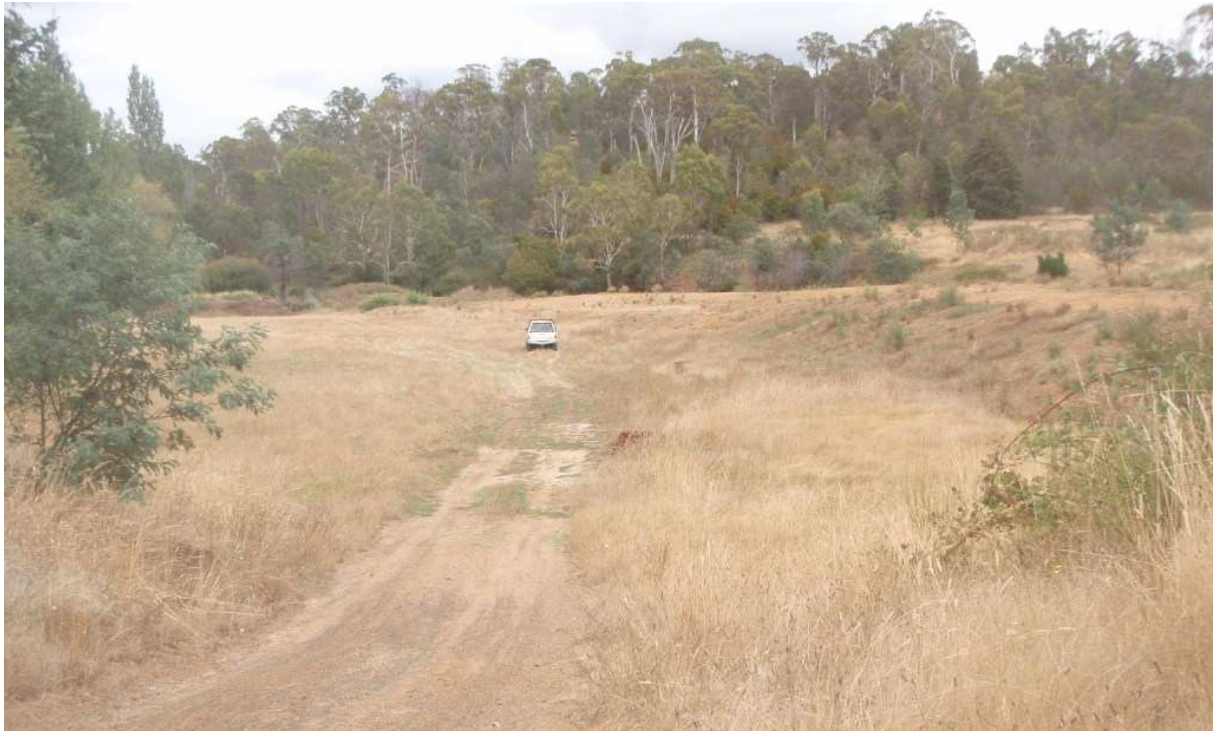
Quite recently, similar silty clay fill has been imported and placed over part of the former oval, to depths of up to about 3m (Plates 3, 4 and 5 in Attachment 9). Placement was apparently not done in an engineered (controlled) manner, so settlement and consolidation is most likely occurring. Mapped as Landslide Zone Class II (Attachment 4).

Plate 5 (above). View looking southwest showing raised fill at right on the former Eastman Oval.

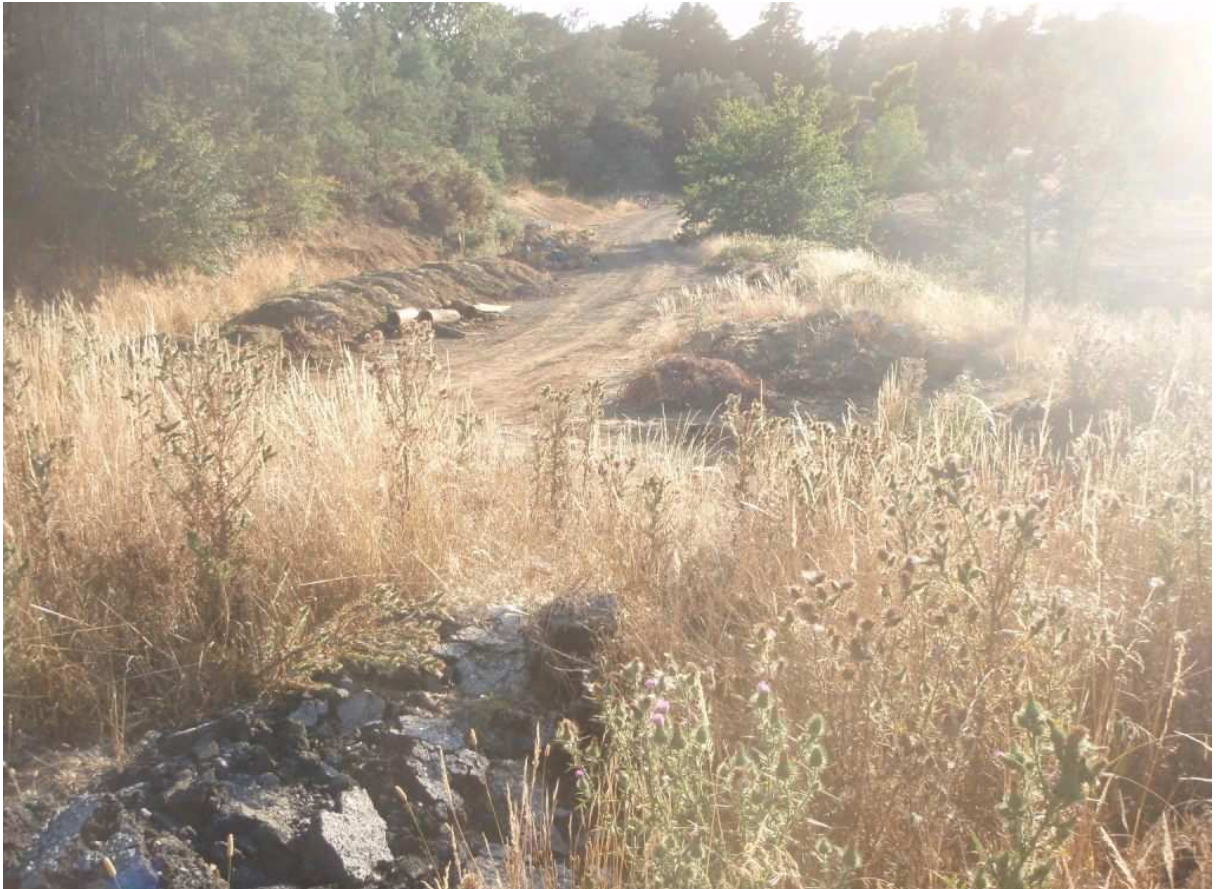
This arcuate area ends at the break of slope of the embankment. Slope angles in the range $5 - 10^{\circ}$, extending upslope to the Thelma Road boundary. Locally modified by the dumping of truckloads of inert fill (Attachment 6, and Plate 7 in Attachment 9) and excavation for the access road for Eastman Oval. Mapped as Landslide Zone Class III (Attachment 4).

Plate 7 (above). View looking east over dumped piles of inert fill (bitumen, concrete, soil) on the slope east of pit I.

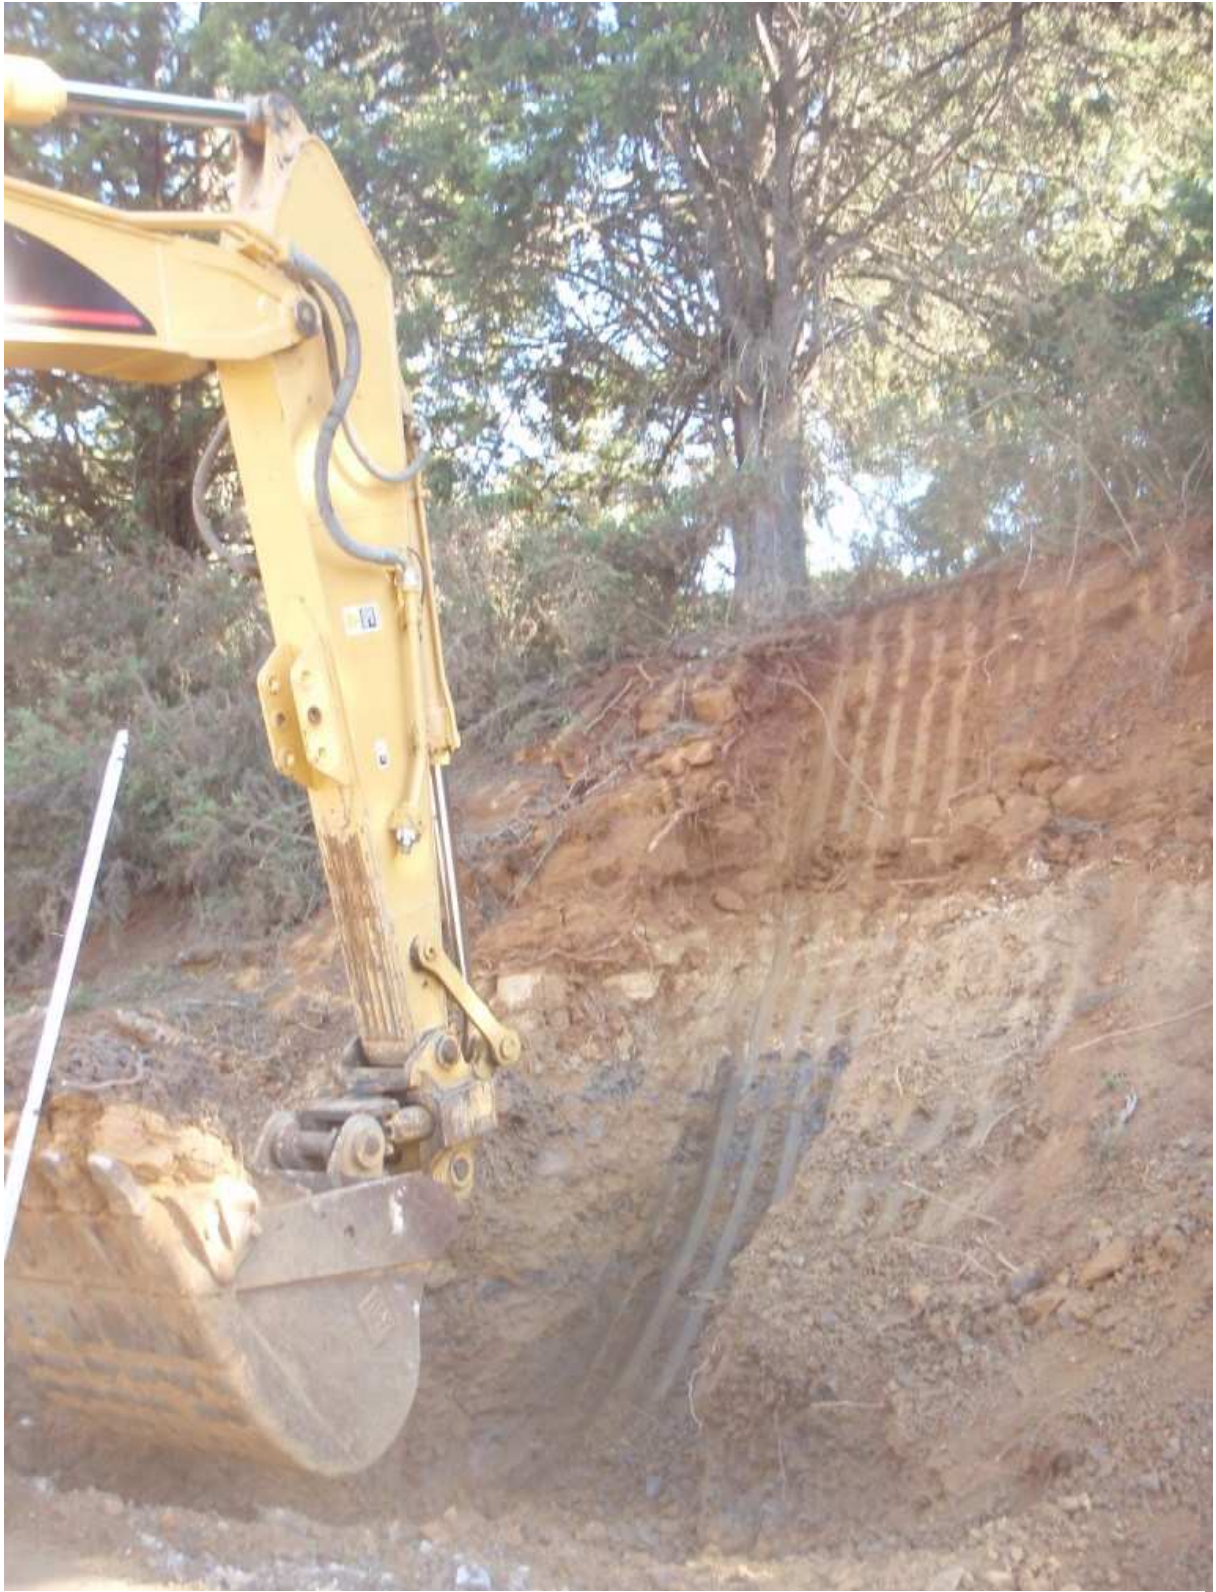
Plate 13. Test pit A exposed lateritic conglomerate (top; orange and light yellow) over dark grey mudstone (bottom). Further digging exposed sandstone under the mudstone. All materials are interpreted as Tertiary in age.

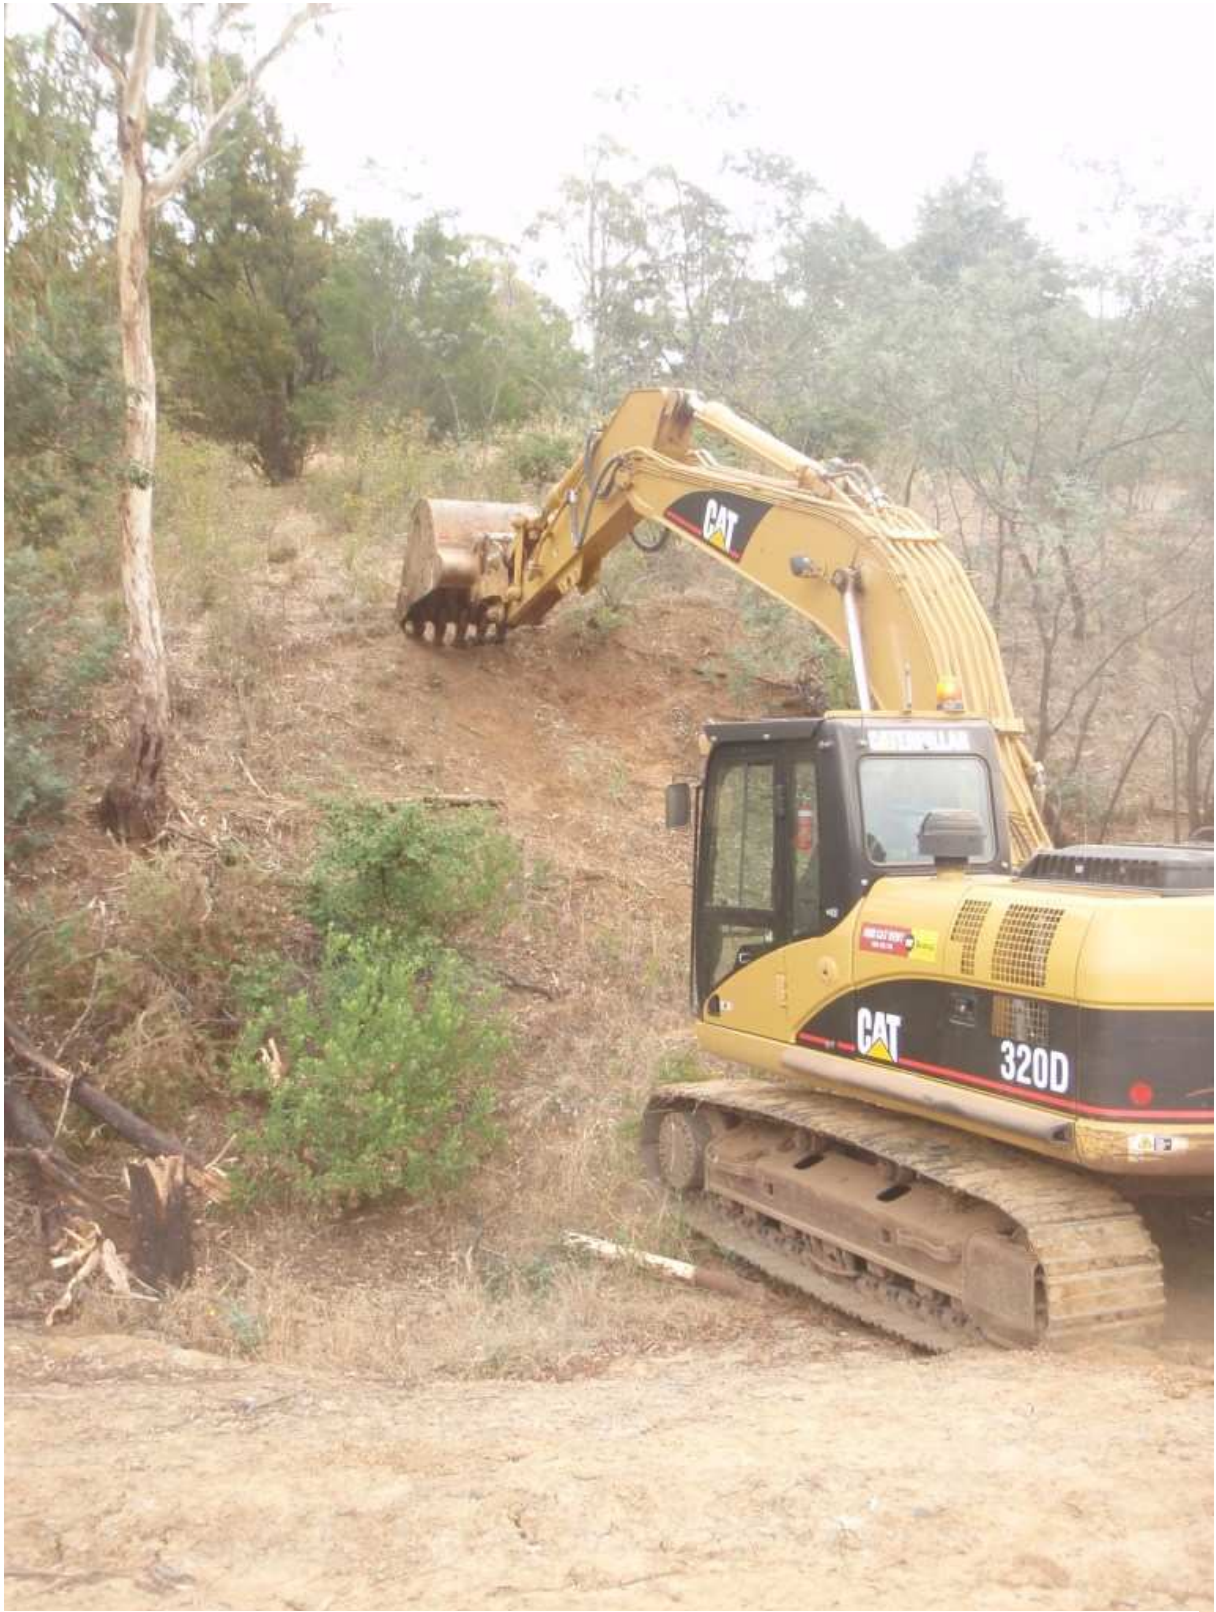
Plate 14. Digging test pit L on the embankment where Tertiary sandstone is exposed.
